Environmental Permit No.: EP-451/2013
Environmental Team for Trunk Road T2

Appendix M – Summary of Exceedance

Reporting Month: January 2021

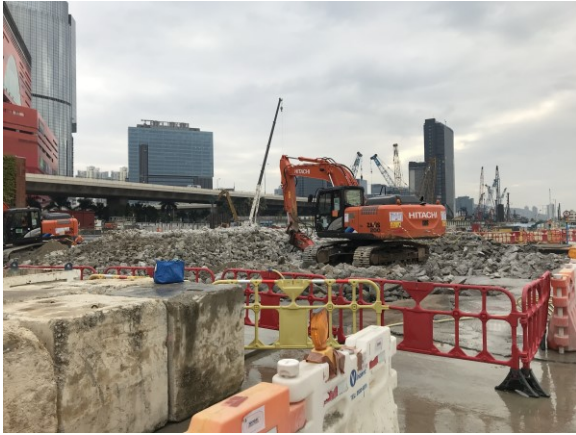
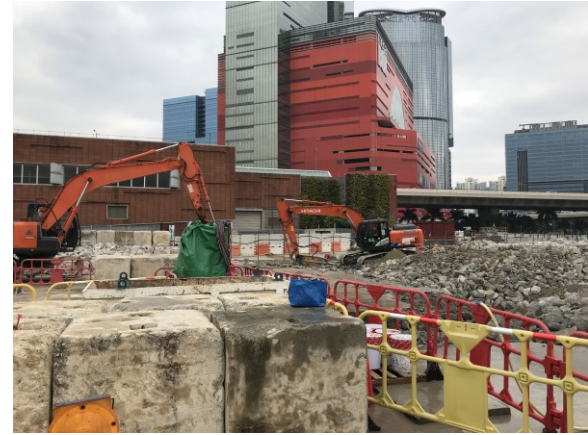
(a) Statement of exceedance(s) 24-hour TSP monitoring measured at KTD 2c on 4 January 2021 exceeded the action level.
(b) Cause of exceedance(s) According to the observation of our field staff, the major dust source(s) and/or reason(s) for exceedance identified at KTD2c is/are as follow: <ol style="list-style-type: none"> 1. Breaking works were carried out near the monitoring station KTD2c. (approximately 5m between the breaker and HVS) (See Photo 1and 2) 2. Dry weather 3. Dust reduction measure, i.e. watering the unpaved road on site, was observed. (See Photo 3 and 4)

Based on the finding(s) and observation(s) above, we deduce the Action Level exceedance of 24-hour TSP recorded at station KTD2c on 04 January 2021 is due to the construction activities were conducted where very close to the HVS. Therefore, the exceedance is considered as project related.

1. Watering of the construction areas 12 times per day to reduce dust emissions.
2. Side enclosure and covering of any aggregate or dusty material storage piles to reduce emissions.
3. Open stockpiles shall be avoided or covered.
4. Tarpaulin covering of all dusty vehicle loads transported to, from and between site locations
5. Establishment and use of vehicle wheel and body washing facilities at the exit points of the site.
6. Imposition of speed controls for vehicles on unpaved site roads, 8 km per hour is the recommended limit

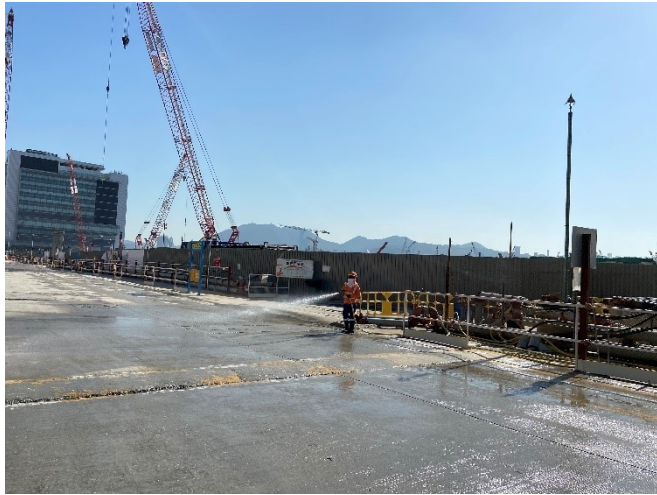
Photo 5 – Watering of main haul road

2. The remedial measures proposed by the contractor was reviewed during site audit and ET has no adverse comments on the proposed remedial measures. The photo records provided by contractor are shown as below:

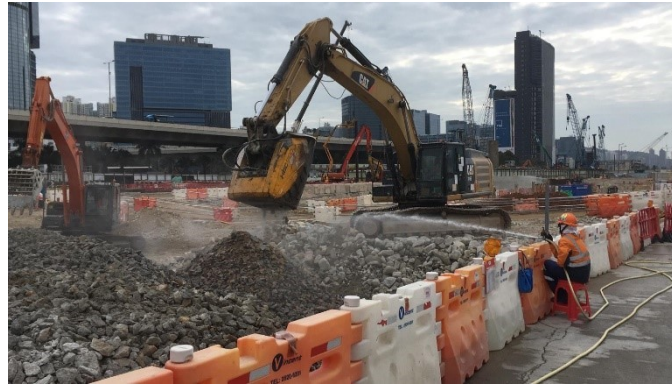
Photo 6 – Water spraying during dusty activities

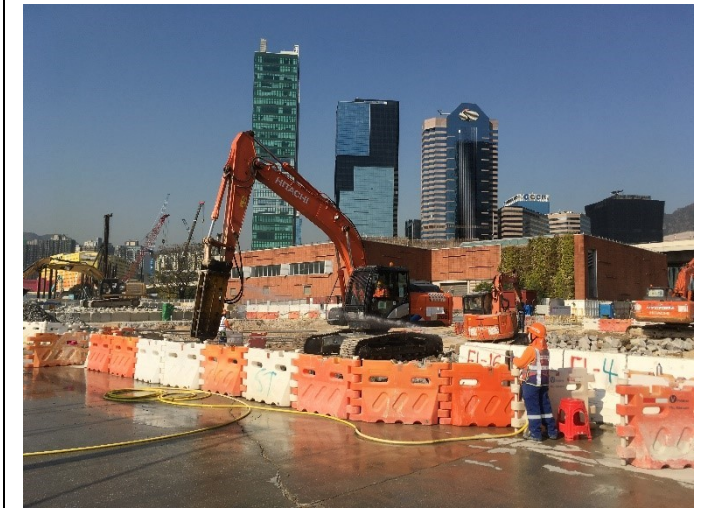
Photo 7 – Water spraying during dusty activities

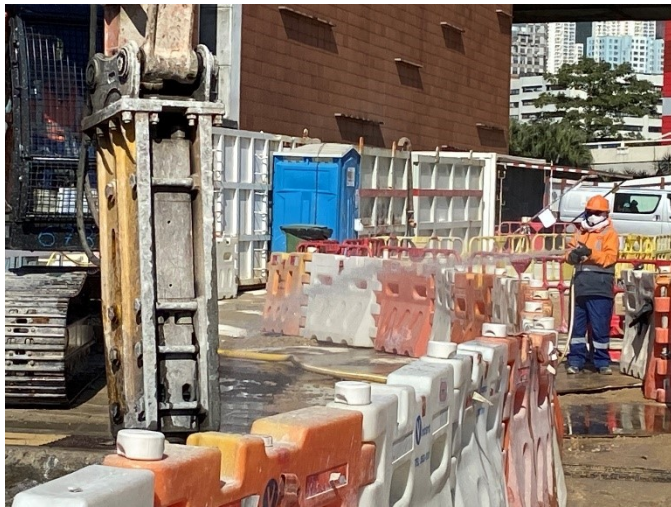
Photo 8 – Water spraying during dusty activities

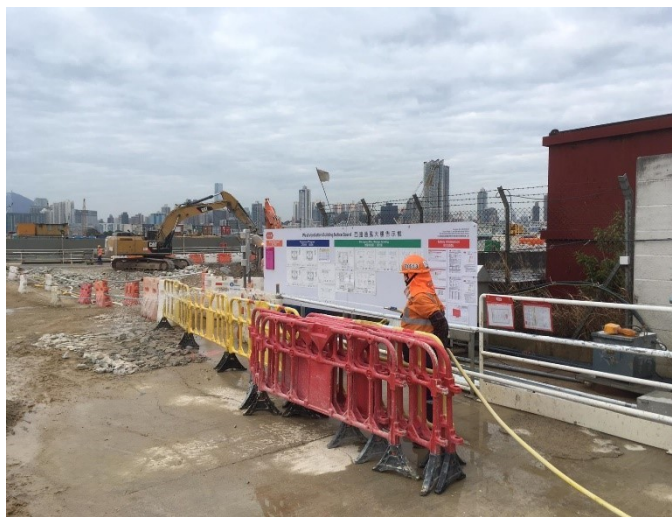
Photo 9 – Watering of unpaved road

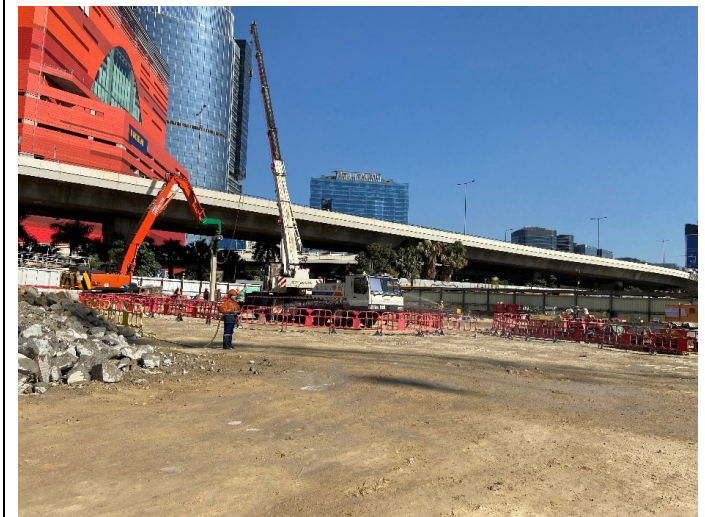
Photo 10 – Watering of unpaved road

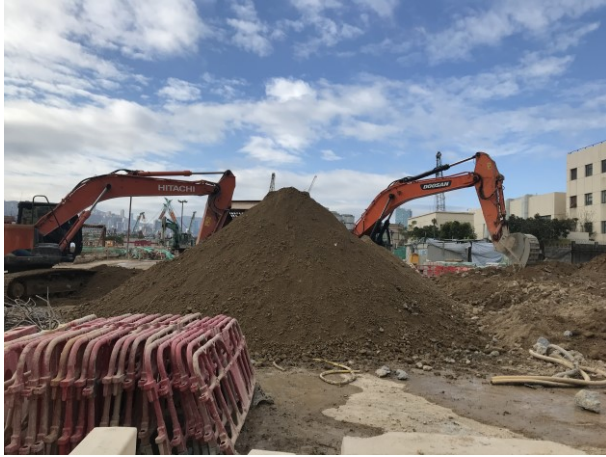
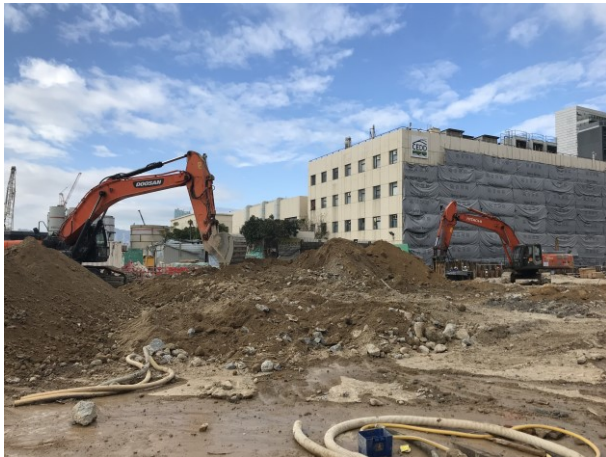
(a)	Statement of exceedance(s) 24-hour TSP monitoring measured at KER1 on 20 January 2021 exceeded the action level.
(b)	Cause of exceedance(s) According to the observation of our field staff, the major dust source(s) and/or reason(s) for exceedance identified at KER1 is/are as follow: 1. Open stockpiles of excavated dusty material were found. (See Photo 1, and Photo 2) 2. Road traffic along Kai Hing Road.

Based on the finding(s) and observation(s) above, we deduce the action level exceedance recorded at KER1 on 20 January was due to the large amount of open stockpiles of excavated dusty material and insufficiency of dust suppression was implemented. Moreover, we deduce the fluctuation of road traffic along Kai Hing Road contributed to the exceedance but not the major dust source. To sum up, the exceedance is considered as project related

1. Watering of the construction areas 12 times per day to reduce dust emissions.
2. Side enclosure and covering of any aggregate or dusty material storage piles to reduce emissions.
3. Open stockpiles shall be avoided or covered.
4. Tarpaulin covering of all dusty vehicle loads transported to, from and between site locations.
5. Establishment and use of vehicle wheel and body washing facilities at the exit points of the site.
6. Imposition of speed controls for vehicles on unpaved site roads, 8 km per hour is the recommended limit.
7. Use of regular watering to reduce dust emissions from exposed site surfaces and unpaved roads, particularly during dry weather.

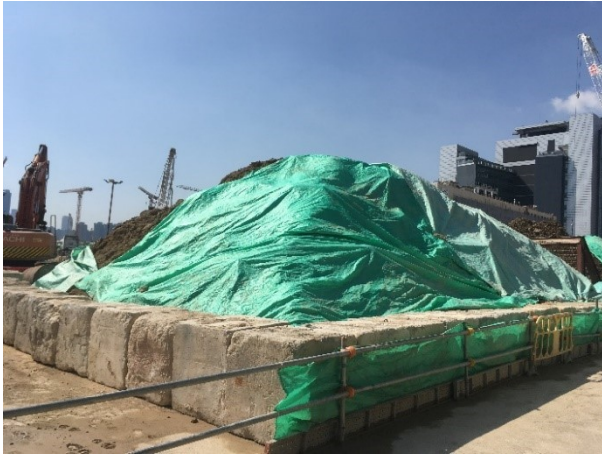
Photo 3 – Tarpaulin covering of open stockpile

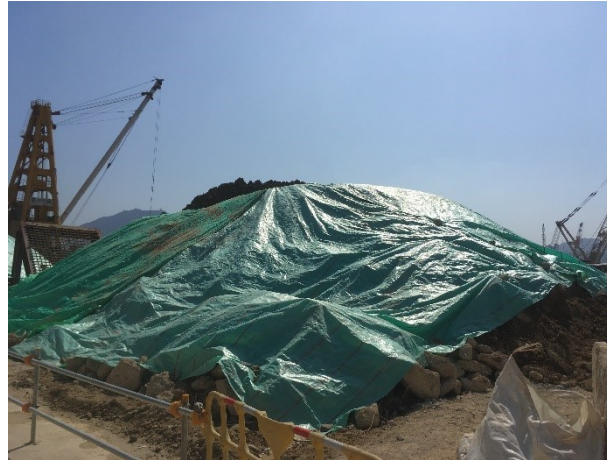
Photo 4 – Tarpaulin covering of open stockpile

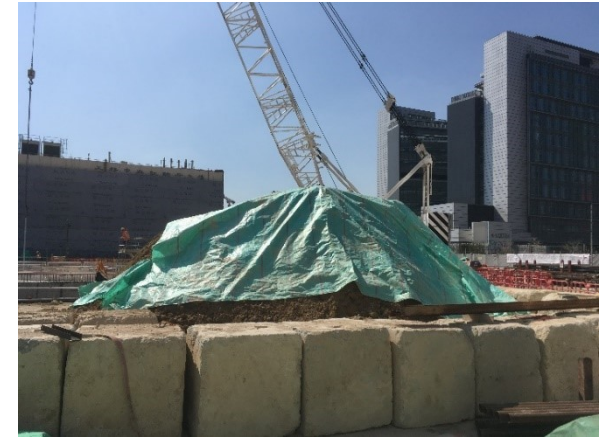
Photo 5 – Tarpaulin covering of open stockpile

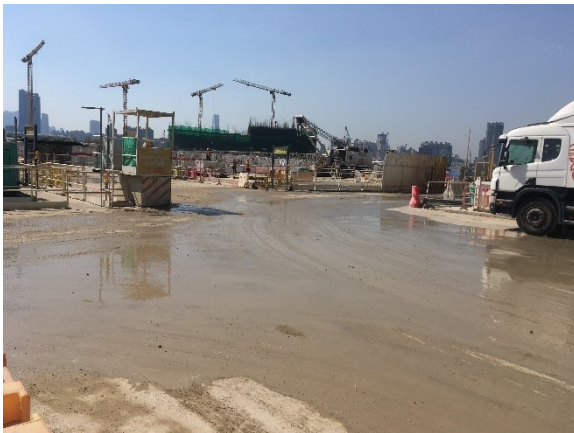
Photo 6 – Watering of main haul road

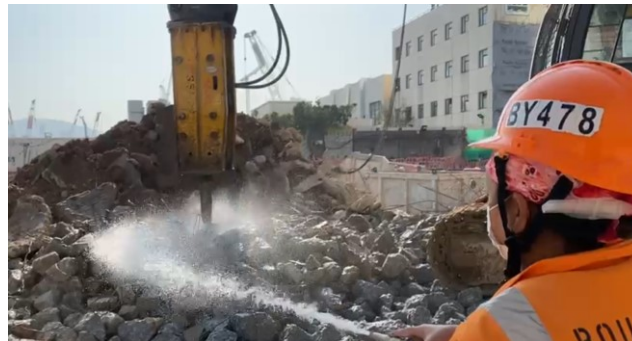
Photo 7 – Water spraying during dusty activities

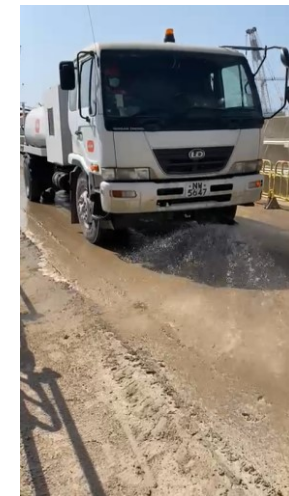
Photo 8 – Watering of main haul road

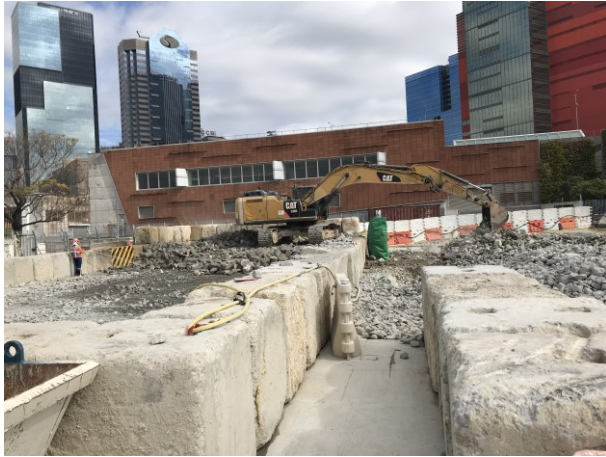
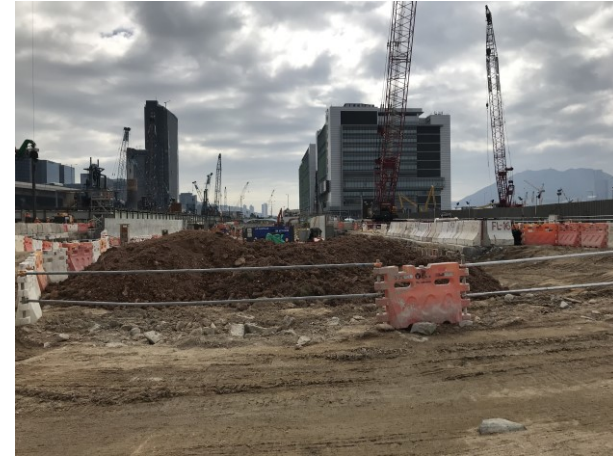
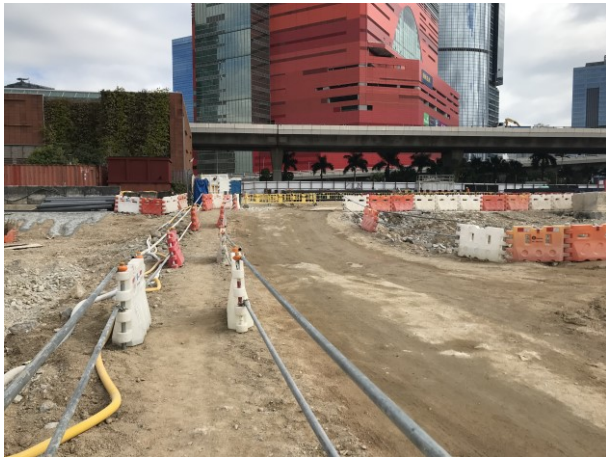
(a) Statement of exceedance(s) 24-hour TSP monitoring measured at KTD2c on 20 January 2021 exceeded the action level.
(b) Cause of exceedance(s) According to the observation of our field staff, the major dust source(s) and/or reason(s) for exceedance identified at KTD2c is/are as follow: <ol style="list-style-type: none"> 1. Material handling was carried out near the monitoring station KTD2c. (approximately 10m between the excavator and HVS) (See Photo 1) . 2. A Stockpile of excavated dusty material with no impervious sheet covered was observed. (See Photo 2) 3. It was observed that unpaved roads were watered to avoid dust generation. (See Photo 3) 4. Road Traffic along the Kwun Tong Bypass.

Based on the finding(s) and observation(s) above, we deduce the action Level exceedance of 24-hour TSP recorded at station KTD2c on 20 January 2021 is due to the insufficiency of dust reduction measure. Also, the construction activities were conducted very close to the HVS. Therefore, the exceedance is considered as project related

1. Watering of the construction areas 12 times per day to reduce dust emissions.
2. Side enclosure and covering of any aggregate or dusty material storage piles to reduce emissions.
3. Open stockpiles shall be avoided or covered.
4. Tarpaulin covering of all dusty vehicle loads transported to, from and between site locations.
5. Establishment and use of vehicle wheel and body washing facilities at the exit points of the site.
6. Imposition of speed controls for vehicles on unpaved site roads, 8 km per hour is the recommended limit.
7. Use of regular watering to reduce dust emissions from exposed site surfaces and unpaved roads, particularly during dry weather.

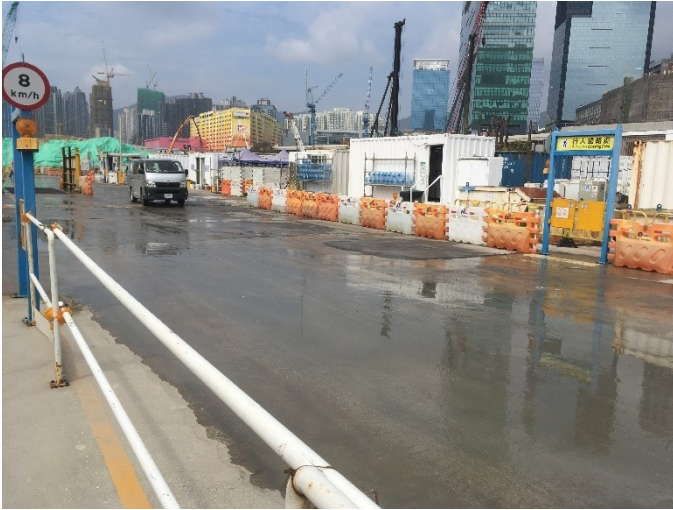
Photo 4 – Watering of main haul road

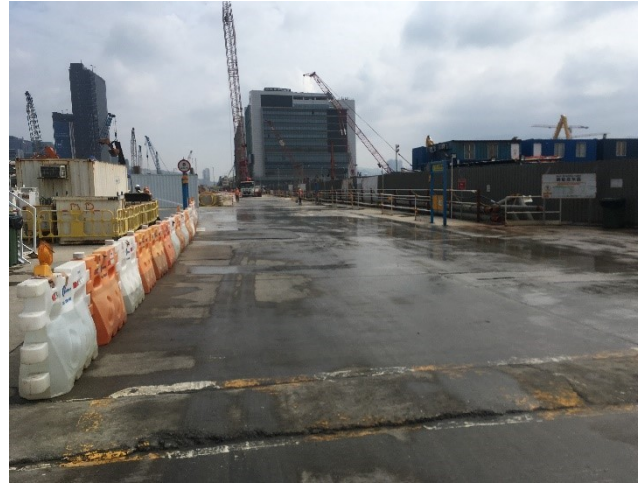
Photo 5 – Watering of main haul road

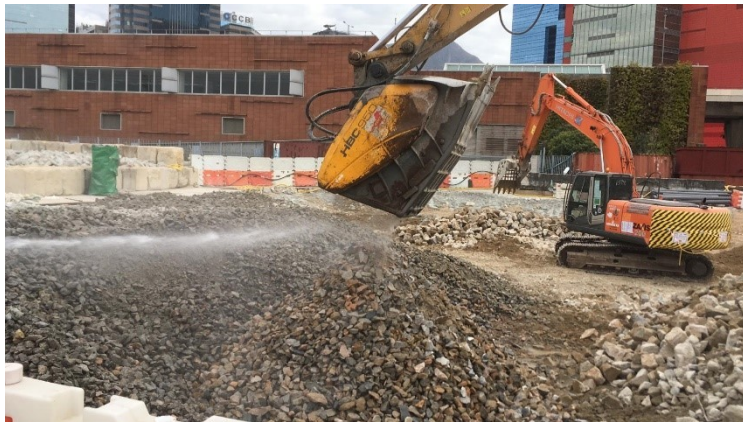
Photo 6 – Water spraying during dusty activities

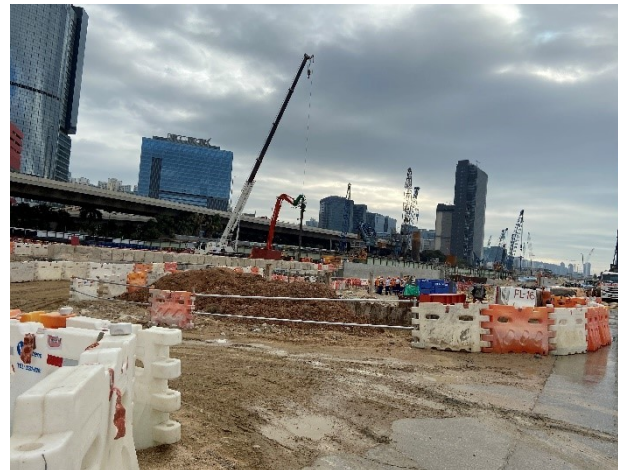
Photo 7 – Watering of unpaved road

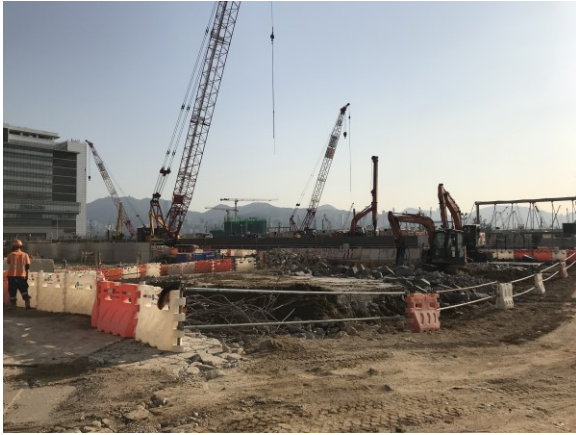
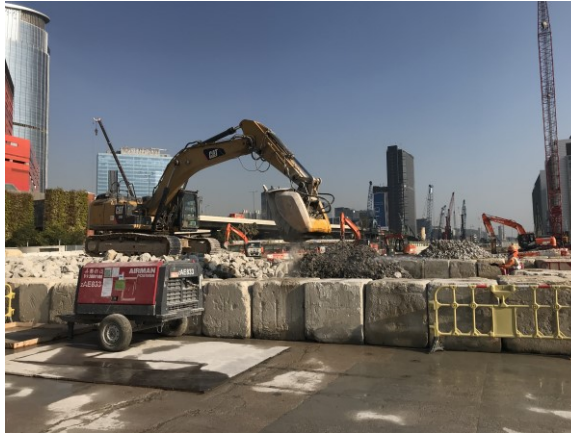
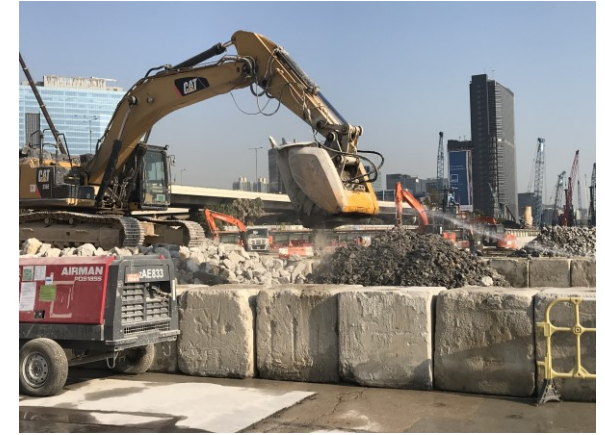
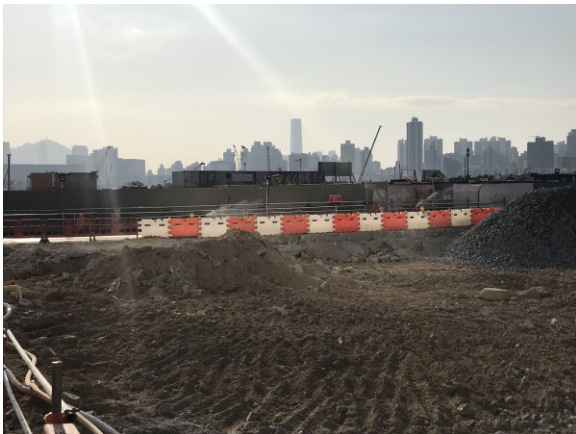
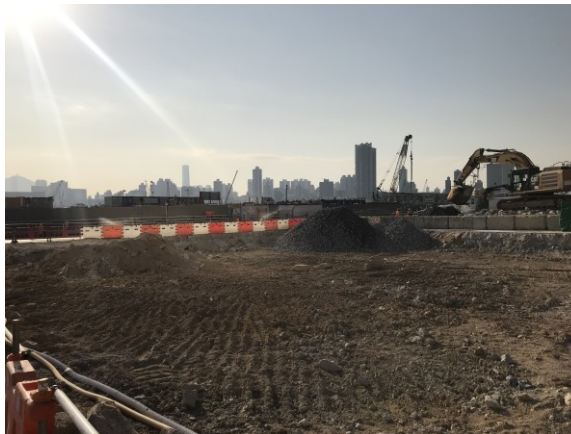
<p>(a) Statement of exceedance(s)</p> <p>24-hour TSP monitoring measured at KTD 2c on 14 January 2021 exceeded the action level.</p>
<p>(b) Cause of exceedance(s)</p> <p>According to the observation of our field staff, the major dust source(s) and/or reason(s) for exceedance identified at KTD2c is/are as follow:</p> <ol style="list-style-type: none"> 1. Breaking works were carried out near the monitoring station KTD2c. (approximately 10m between the breaker and HVS) (See Photo 1) 2. Observable dust sources, such as wind erosion, loading and unloading of material, and vehicle movement on site, were identified. 3. Crashing of material with watering was conducted next to the monitoring station. (approximately 15m between the excavator mounted bucket crusher and HVS) (See Photo 2 and 3). 4. Dust reduction measure, i.e. watering the unpaved road on site, was observed. 5. A Stockpile of excavated dusty material with no impervious sheet covered was observed. (See Photo 4 and 5)

Based on the finding(s) and observation(s) above, it was observed that insufficient dust reduction measure was carried out to reduce emission during crashing activity, and the construction activities were conducted very close to the HVS. Therefore, the exceedance is considered as project related.

1. Watering of the construction areas 12 times per day to reduce dust emissions.
2. Side enclosure and covering of any aggregate or dusty material storage piles to reduce emissions.
3. Open stockpiles shall be avoided or covered.
4. Tarpaulin covering of all dusty vehicle loads transported to, from and between site locations.
5. Establishment and use of vehicle wheel and body washing facilities at the exit points of the site.
6. Imposition of speed controls for vehicles on unpaved site roads, 8 km per hour is the recommended limit.
7. Use of regular watering to reduce dust emissions from exposed site surfaces and unpaved roads, particularly during dry weather.

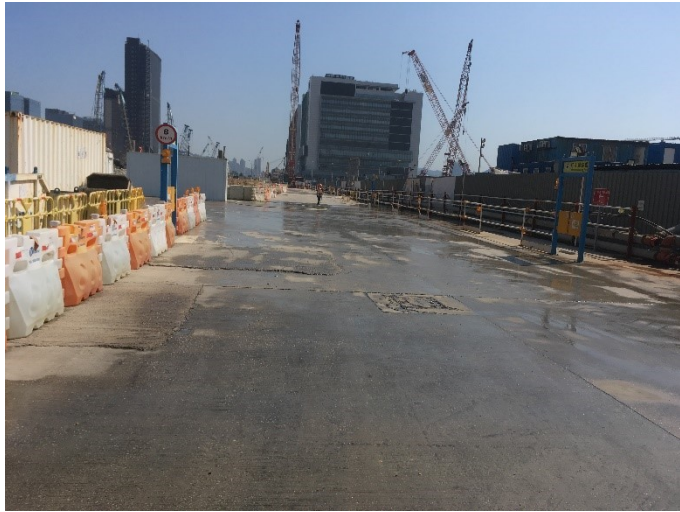
Photo 6 – Watering of main haul road

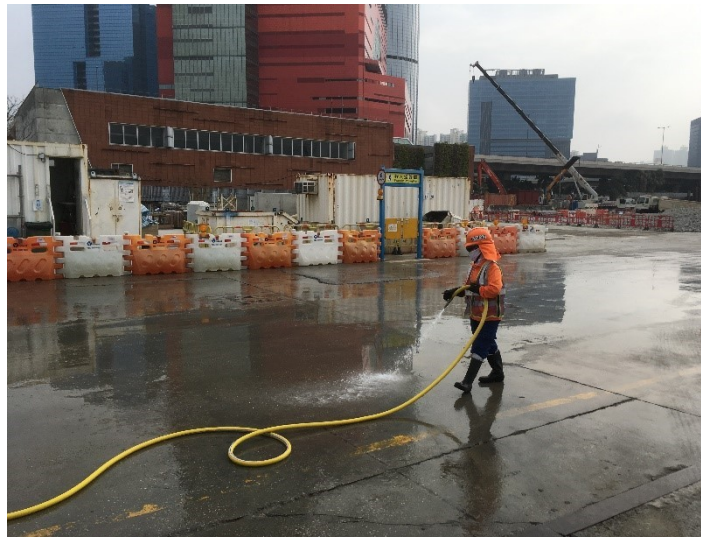
Photo 7 – Watering of main haul road

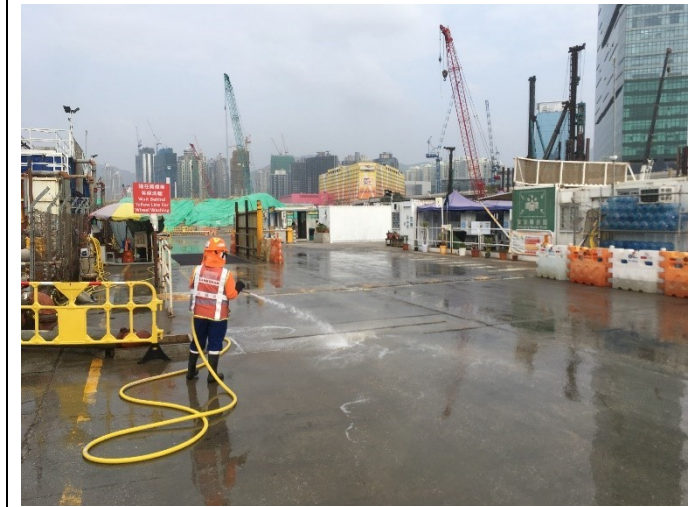
Photo 8 – Watering of main haul road

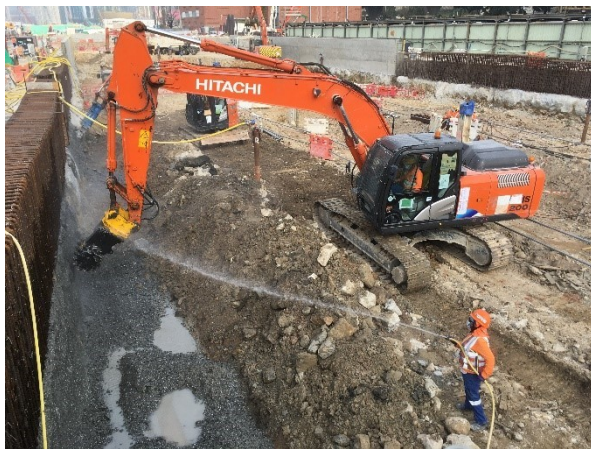
Photo 9 – Water spraying during dusty activities

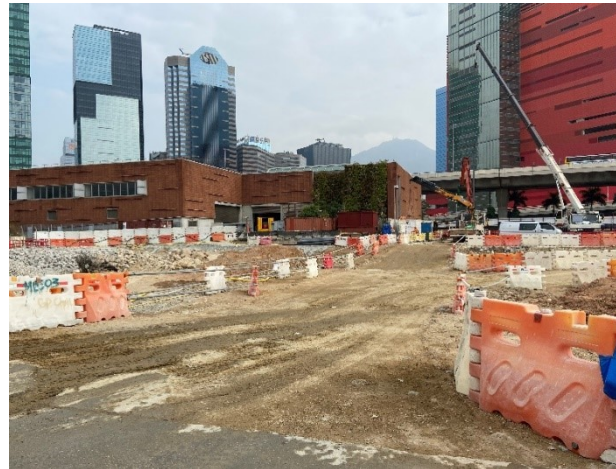
Photo 10 – Watering of unpaved road

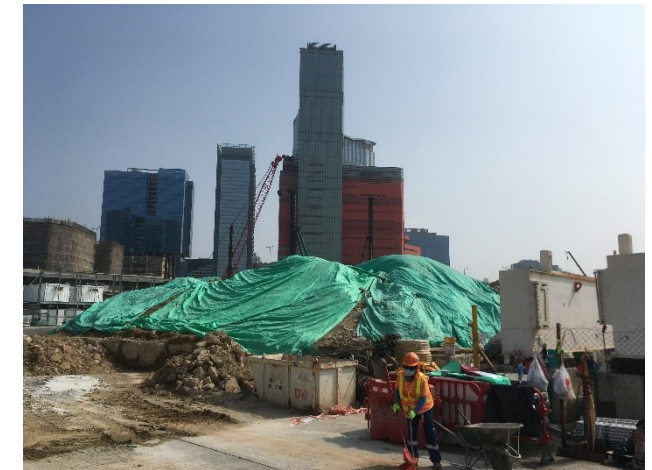
Photo 11 – Tarpaulin covering of open stockpile

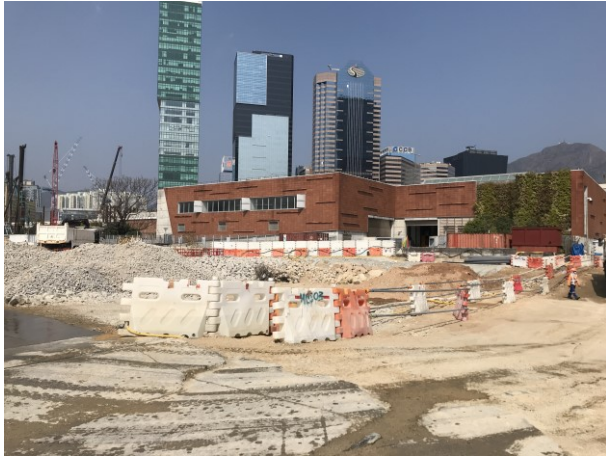
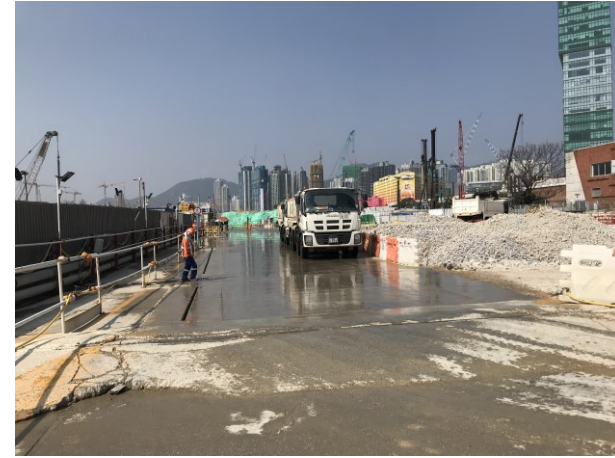
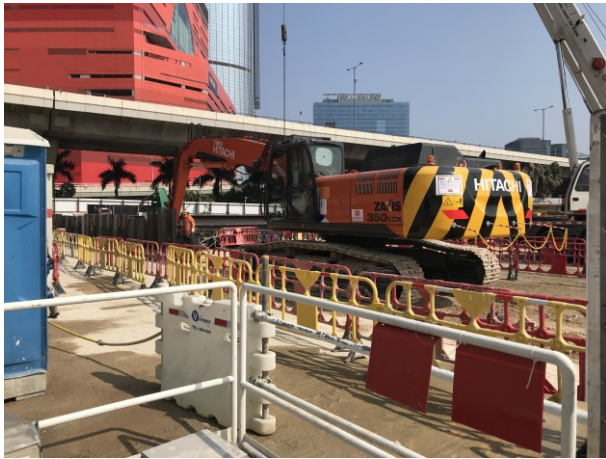
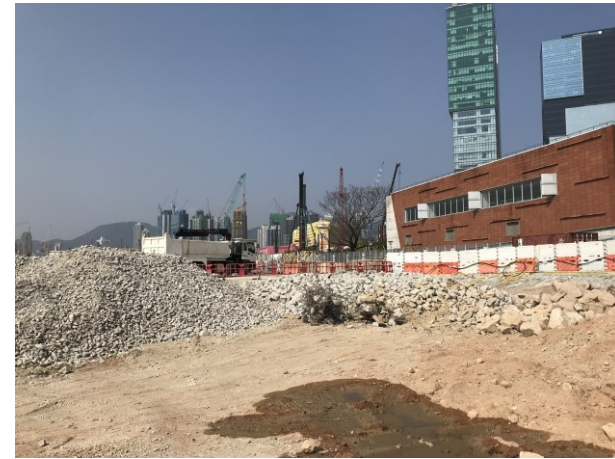
(a) Statement of exceedance(s) 24-hour TSP monitoring measured at KTD2c on 26 January 2021 exceeded the action level.
(b) Cause of exceedance(s) According to the observation of our field staff, the major dust source(s) and/or reason(s) for exceedance identified at KTD2c is/are as follow: <ol style="list-style-type: none"> 1. A stockpile of excavated dusty material with no impervious sheet covered was observed. (See Photo 1 and Photo 4) 2. Road Traffic along the Kwun Tong Bypass 3. It was observed that paved roads were watered to avoid dust generation. (See Photo 2) 4. Piling work was carried out near the monitoring station KTD2c. (approximately 5m) (See Photo 3).

Based on the finding(s) and observation(s) above, we deduce the action Level exceedance of 24-hour TSP recorded at station KTD2c on 26 January 2021 is due to the insufficiency of dust reduction measure. Also, the construction activities were conducted very close to the HVS. Therefore, the exceedance is considered as project related.

1. Watering of the construction areas 12 times per day to reduce dust emissions.
2. Side enclosure and covering of any aggregate or dusty material storage piles to reduce emissions.
3. Open stockpiles shall be avoided or covered.
4. Tarpaulin covering of all dusty vehicle loads transported to, from and between site locations.
5. Establishment and use of vehicle wheel and body washing facilities at the exit points of the site.
6. Imposition of speed controls for vehicles on unpaved site roads, 8 km per hour is the recommended limit.
7. Use of regular watering to reduce dust emissions from exposed site surfaces and unpaved roads, particularly during dry weather.

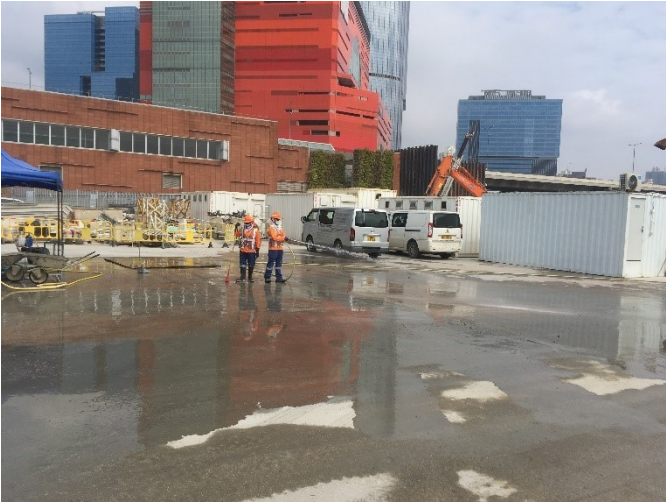
Photo 5 – Watering of main haul road

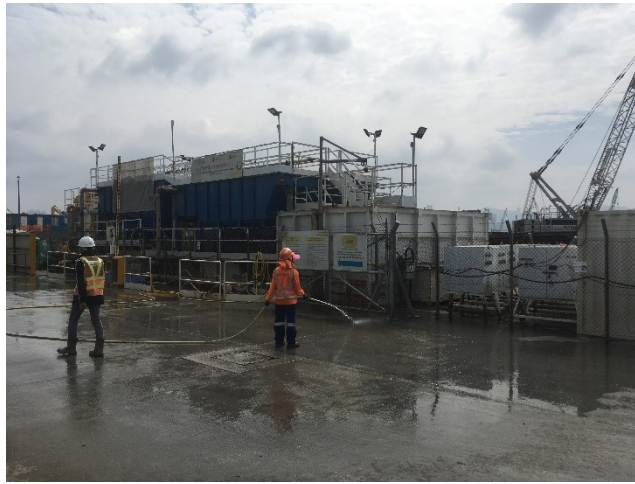
Photo 6 – Watering of main haul road

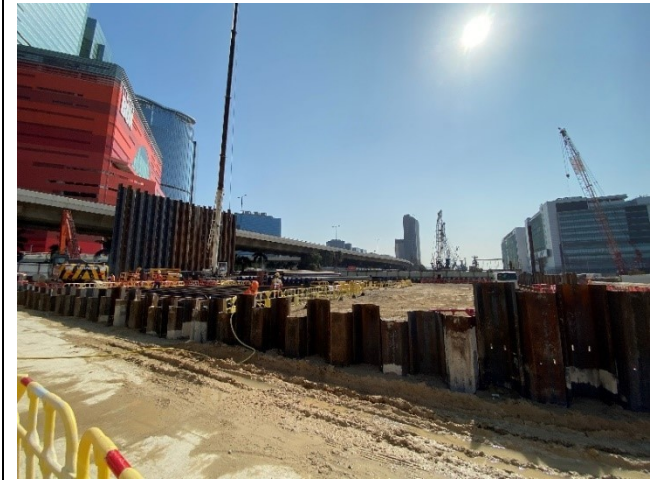
Photo 7 – Water spraying during dusty activities

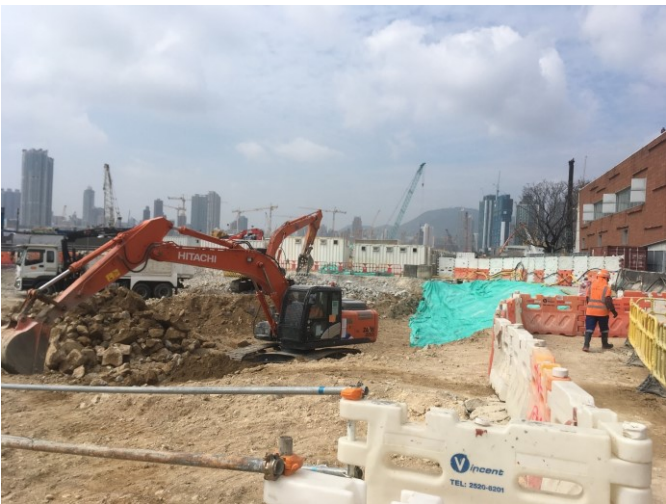
Photo 8 – Tarpaulin covering of open stockpile

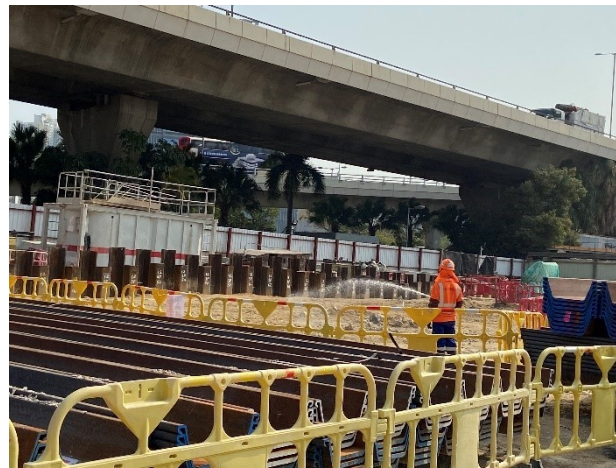
Photo 9 – Watering of unpaved road
