Environmental Permit No.: EP-451/2013
Environmental Team for Trunk Road T2

Appendix M – Summary of Exceedance

Reporting Month: February 2021

NOE No. 210201_24hrTSP (KTD2c) **Exceedance Level:** Action

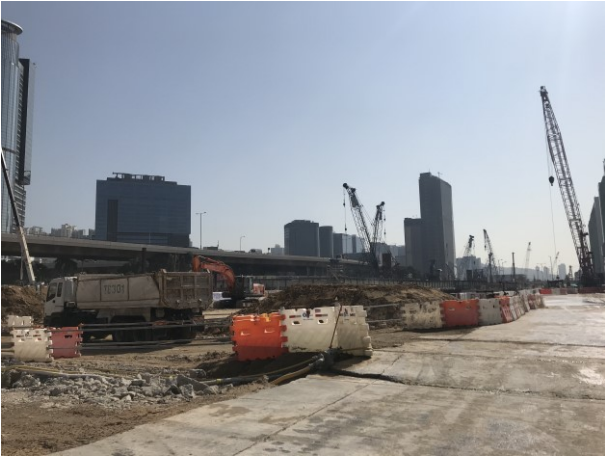
Photo 1

<p>(a) Statement of exceedance(s)</p> <p>24-hour TSP monitoring measured at KTD2c on 01 February 2021 exceeded the action level.</p>
<p>(b) Cause of exceedance(s)</p> <p>According to the observation of our field staff, the major dust source(s) and/or reason(s) for exceedance identified at KTD2c is/are as follow:</p> <ol style="list-style-type: none"> 1. Several spoil heaps were identified around the monitoring station.(See Photo 1, 2 and 3) 2. Road Traffic along the Kwun Tong Bypass 3. It was observed that paved roads were watered.(See Photo 5) 4. Piling work was carried out near the monitoring station KTD2c. (approximately 5m) (See Photo 4) 5. Handling of C&D material was carried out near the monitoring station. (approximately 5m) (See Photo 2 and 3)
