Contract No. ED/2018/04

Trunk Road T2 and Infrastructure Works for Developments at the Former South Apron

Appendix N – Summary of Exceedance

Reporting Period: September 2021

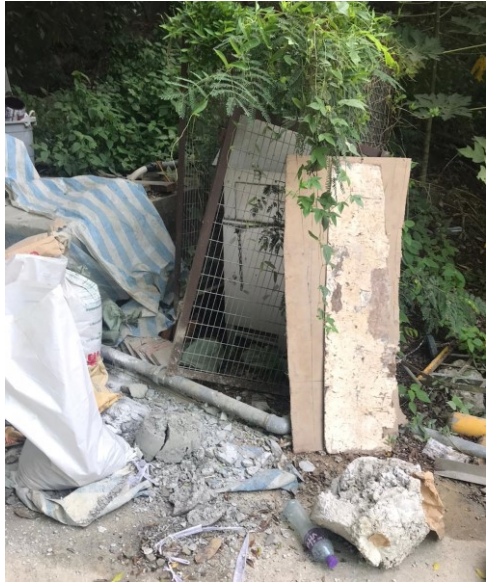
<p>(a) Statement of exceedance(s) 24-hour TSP monitoring measured at AM1 on 15 and 28 September 2021 exceeded the limit and action level respectively.</p>
<p>(b) Cause of exceedance(s) According to the observation of our field staff, the major dust source(s) and/or reason(s) for exceedance identified at AM1 is/are as follow:</p> <ol style="list-style-type: none"> 1. Renovation of Tin Hau Temple began in mid-May 2021. 2. According to our field observation, piles of renovation material were scattered around Tin Hau Temple during the monitoring period (see the photo record). Frequent material transportation may cause dust nuisance to the surrounding 3. Dust generating activities (cement mixing) by renovation staff was observed on-site 4. Joss paper furnace was found right next to the HVS, which may affect the result if incense burning was conducted. 5. Non-project related construction works (TKOLTT project) 6. Road traffic along Cha Kwo Ling Road 7. RE and Contractor have confirmed that no construction activity was carried out in the vicinity of the Tin Hau Temple on 15-16 and 28-29 September 2021 under this contract.

Photo 1 – Recent condition of the High Volume Sampler (HVS) at AM1, Tin Hau Temple. Debris and waste were scattered around the HVS (Taken on 29 Sep 2021)

Based on the finding(s) and observation(s) above, we deduce the Limit Level and Action Level exceedance of 24-hour TSP recorded at station AM1 on 15 & 28 September 2021 respectively are due to the non-project related influence. Therefore, the exceedance is considered as **non-project related**.

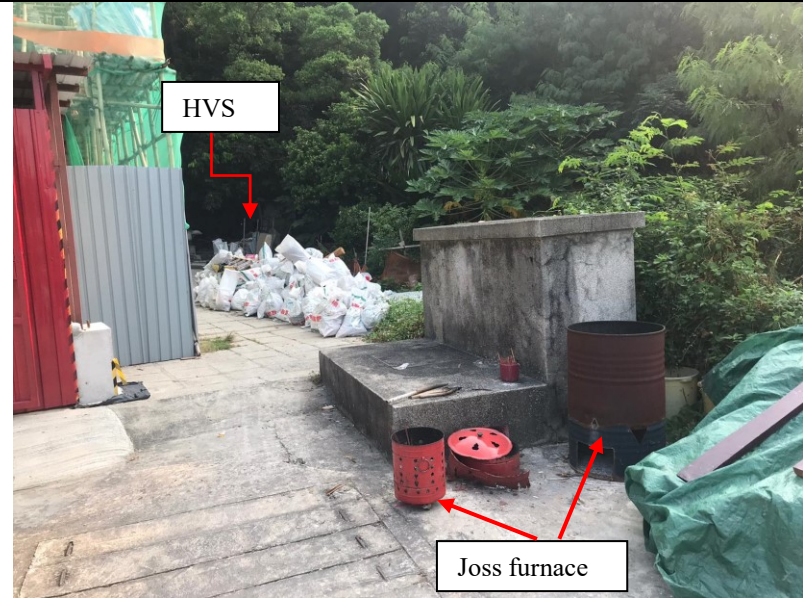
Photo 2 – The HVS was swallowed by bags of dusty materials and the joss furnace located near the HVS. (Taken on 29 Sep 2021)

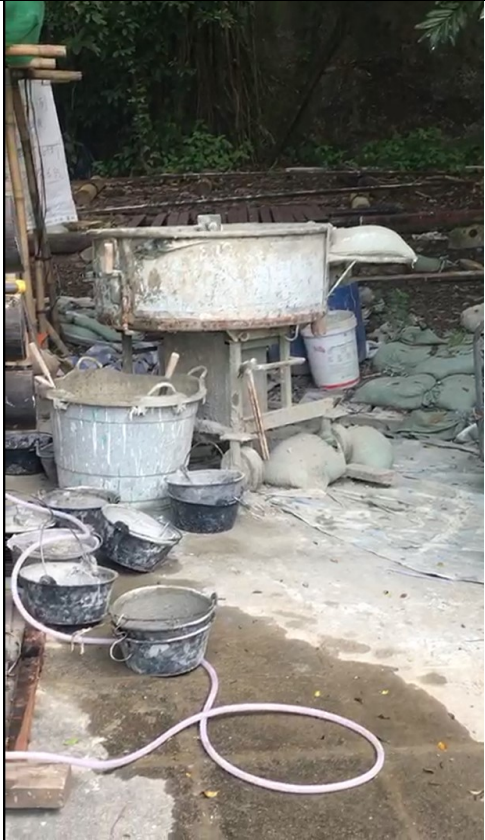
Video Screenshot 1 - Cement mixing carried out by the worker of Temple renovation work

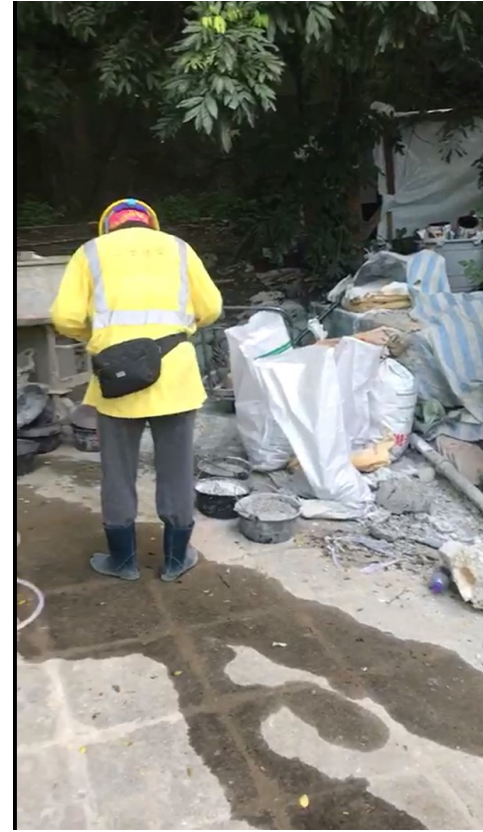
Video Screenshot 2 - Cement mixing carried out by the worker of Temple renovation work
