## MONTHLY EM&A REPORT

July 2018

**Contract Name** : Environmental Monitoring Works for  
Contract KL/2014/03 – Kai Tak Development  
– Stage 3 Infrastructure Works for Developments  
at the Southern Part of the Former Runway

**Report No.** : 0405/15/ED/1080A

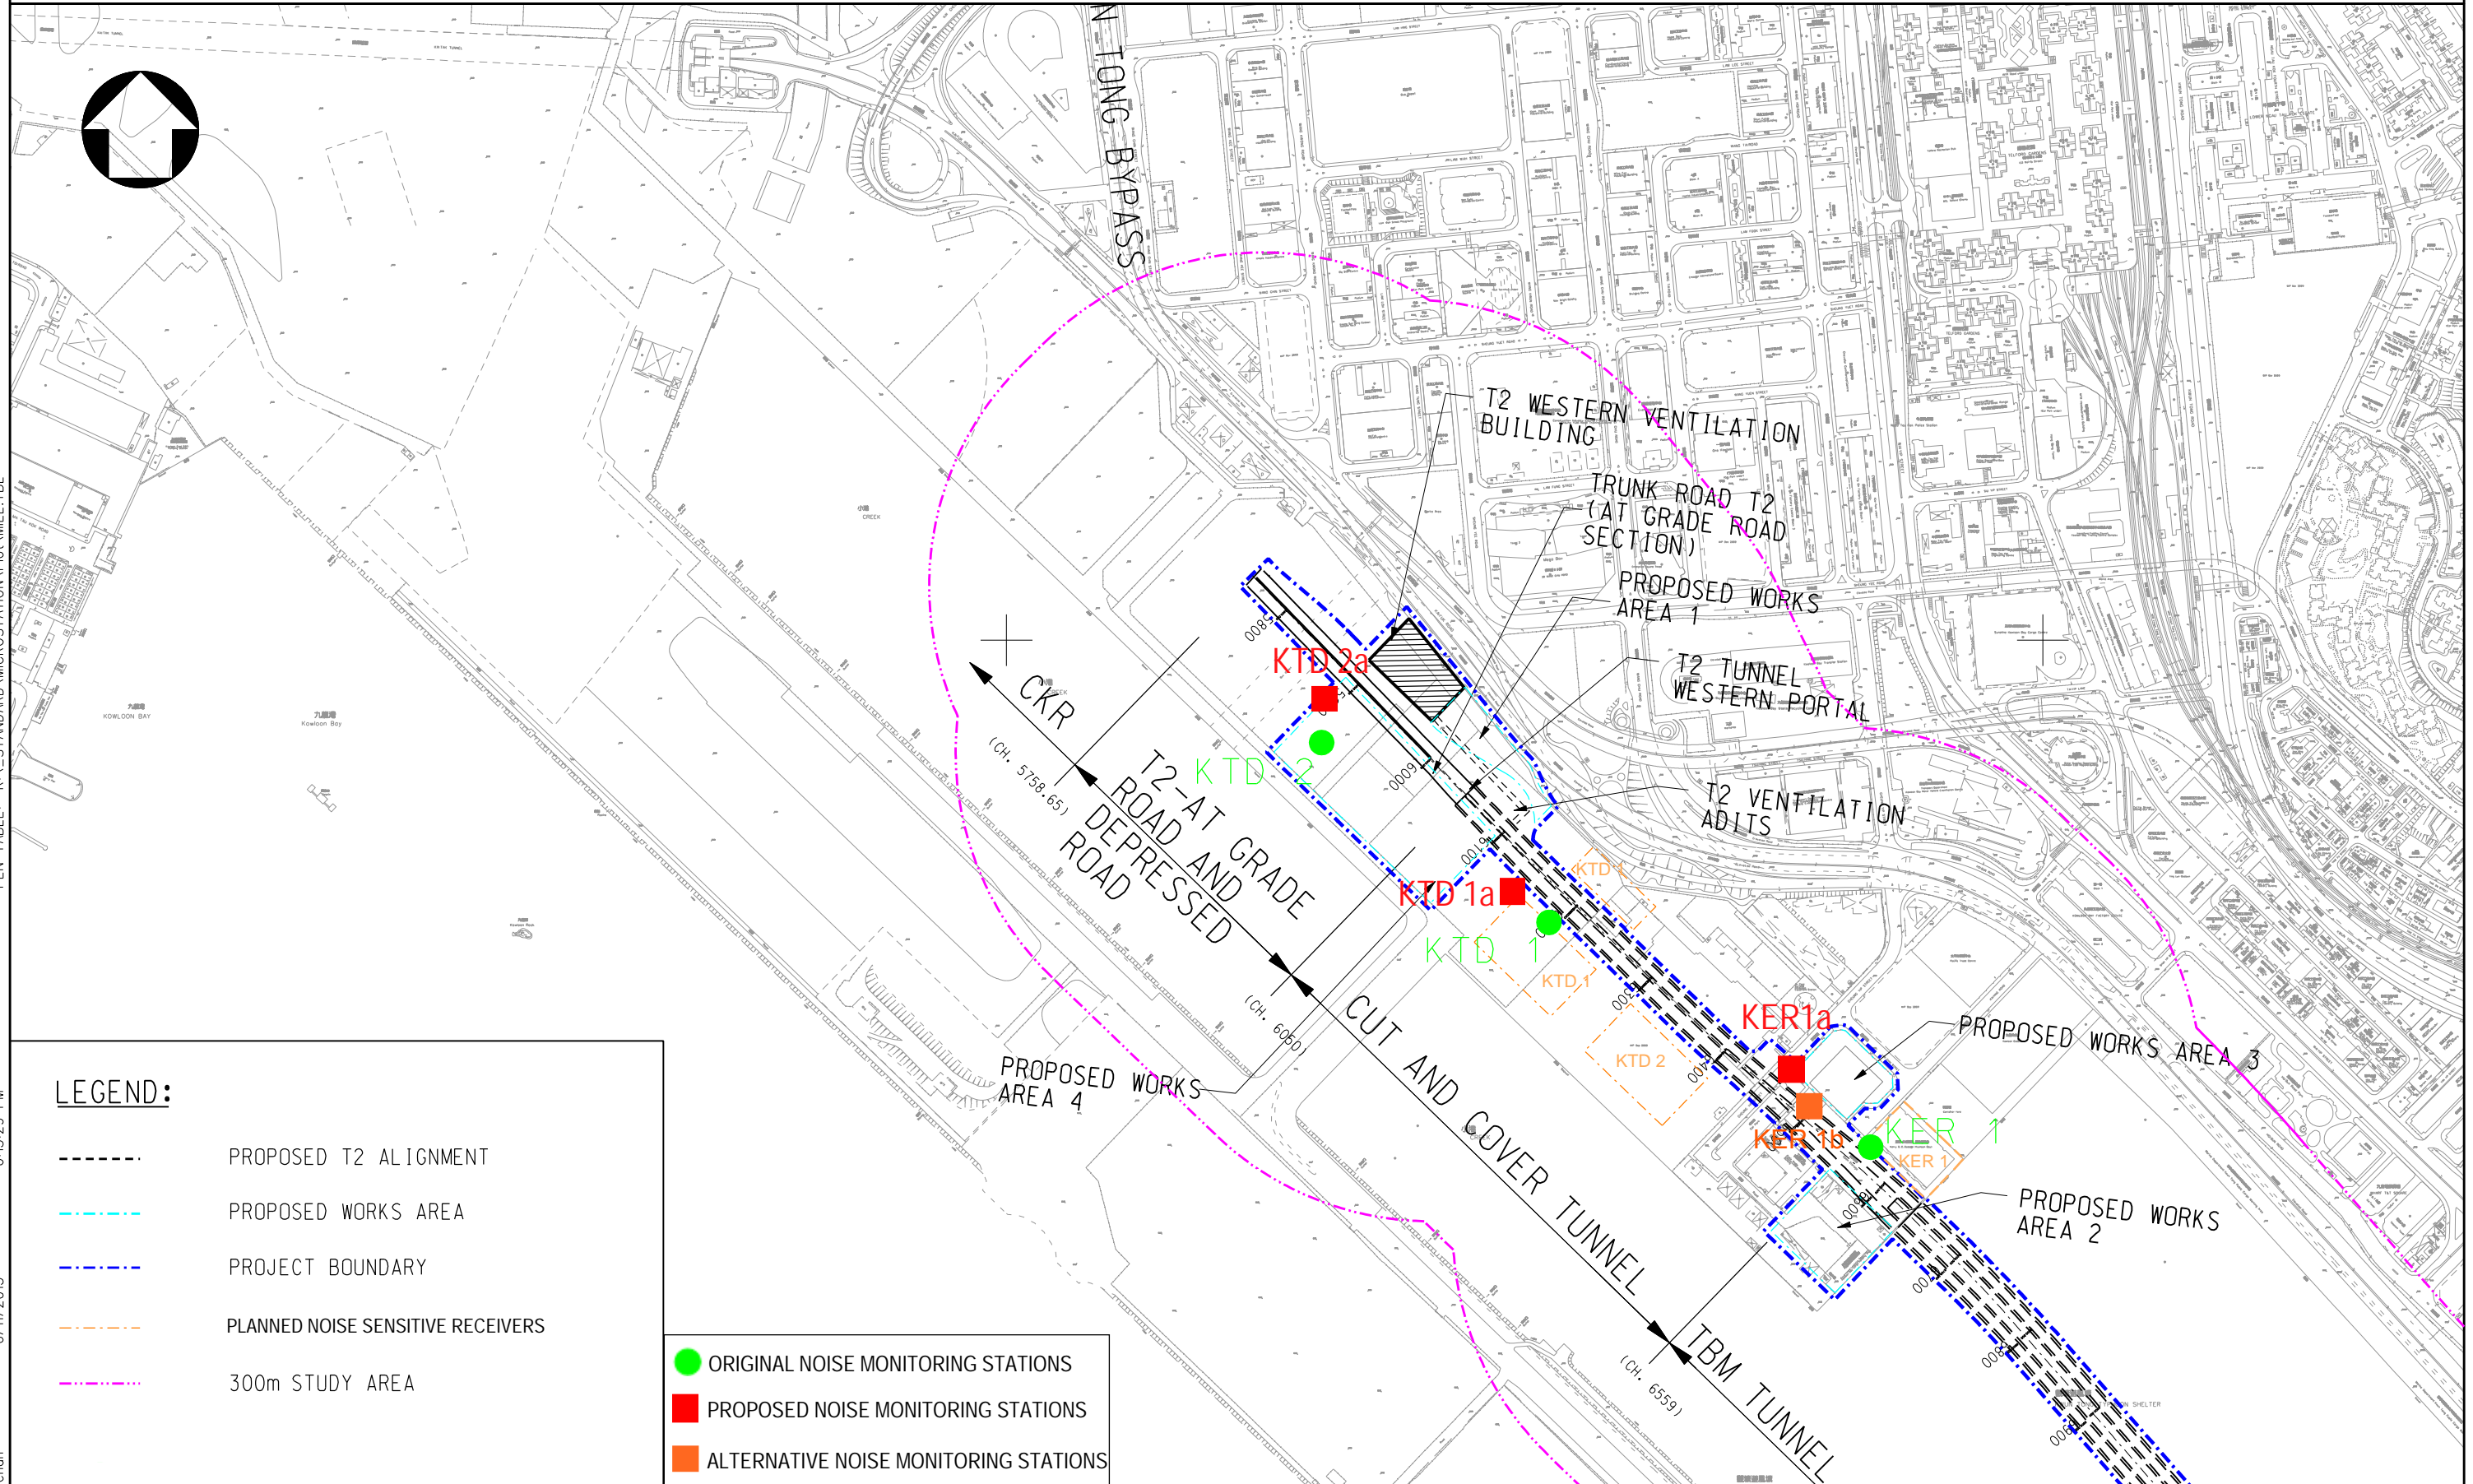
### **Figure 2**

#### **Air and Noise Monitoring Locations**

Drawing title <b>IDENTIFIED DUST MONITORING STATIONS AT SOUTH APRON OF FORMER KAI TAK AIRPORT</b>	Original Size <b>A3</b>	Scale 1 : 6000	Date 30/01/2012
			File name Drawing No.		Rev. --
© Copyright reserved			<b>FIGURE 2.1a(revised)</b>

2.5.2 According to the approved alternative baseline air quality and noise monitoring locations (EPD reference: EP2/K19/A/21 Pt.5), the original monitoring locations (KTD1, KTD2 and KER1) are proposed to be replaced by alternative monitoring locations (KTD1a, KTD2a and KER1b) for air quality monitoring, they are summarized in **Table 2.2** and shown in **Figure 2**.

3.6.2 According to the approved alternative baseline air quality and noise monitoring locations (EPD reference: EP2/K19/A/21 Pt.5), the original monitoring locations (KTD1, KTD2 and KER1) are proposed to be replaced by alternative monitoring locations (KTD1a, KTD2a and KER1b) for noise monitoring, they are summarized in **Table 3.3** and shown in **Figure 2**.
