Environmental Permit No.: EP-451/2013
Environmental Team for Trunk Road T2

Appendix M – Summary of Exceedance

Reporting Month: February 2021

NOE No. 210201_24hrTSP (KTD2c) **Exceedance Level:** Action

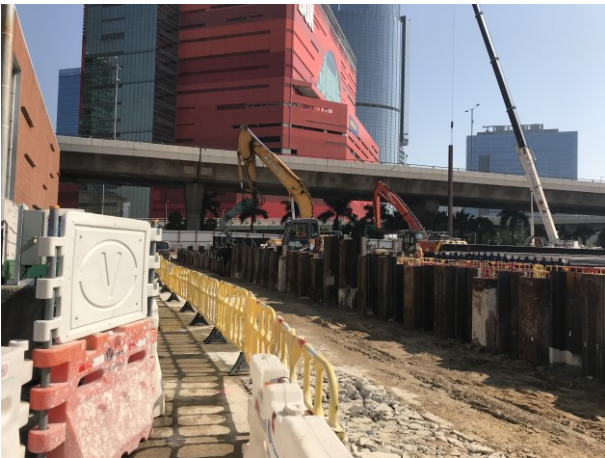
Photo 4

<p>(a) Statement of exceedance(s)</p> <p>24-hour TSP monitoring measured at KTD2c on 01 February 2021 exceeded the action level.</p>
<p>(b) Cause of exceedance(s)</p> <p>According to the observation of our field staff, the major dust source(s) and/or reason(s) for exceedance identified at KTD2c is/are as follow:</p> <ol style="list-style-type: none"> 1. Several spoil heaps were identified around the monitoring station.(See Photo 1, 2 and 3) 2. Road Traffic along the Kwun Tong Bypass 3. It was observed that paved roads were watered.(See Photo 5) 4. Piling work was carried out near the monitoring station KTD2c. (approximately 5m) (See Photo 4) 5. Handling of C&D material was carried out near the monitoring station. (approximately 5m) (See Photo 2 and 3)

1. Watering of the construction areas 12 times per day to reduce dust emissions.
2. Side enclosure and covering of any aggregate or dusty material storage piles to reduce emissions.
3. Open stockpiles shall be avoided or covered.
4. Tarpaulin covering of all dusty vehicle loads transported to, from and between site locations.
5. Establishment and use of vehicle wheel and body washing facilities at the exit points of the site.
6. Imposition of speed controls for vehicles on unpaved site roads, 8 km per hour is the recommended limit.
7. Use of regular watering to reduce dust emissions from exposed site surfaces and unpaved roads, particularly during dry weather.
