### Contract No. ED/2018/04

## Trunk Road T2 and Infrastructure Works for Developments at the Former South Apron

# **Appendix N – Summary of Exceedance**

**Reporting Period: June 2021**

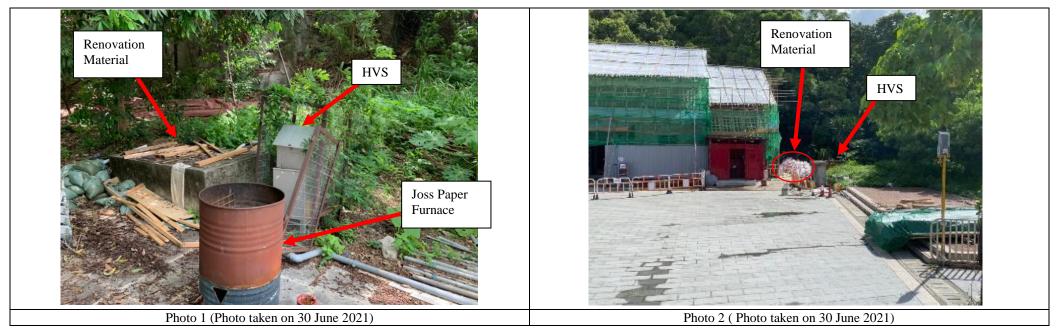
Photo Record (Photo Taken by ET)

- 1. Renovation of Tin Hau Temple began in mid-May 2021.
- 2. Piles of renovation material were scattered around Tin Hau Temple during the monitoring period (See Photo 1 and 2). Frequent material transportation may cause dust nuisance to the surrounding.
- 3. Joss paper furnace was found right next to the HVS, which may affect the result if incense burning was conducted.
- 4. Non-project related construction works (TKOLTT project)
- 5. Road traffic along Cha Kwo Ling Road
- 6. RE and Contractor have confirmed that no construction activity was carried out in the vicinity of the Tin Hau Temple on 30 June 2021 1 July 2021 under this contract.

Based on the finding(s) and observation(s) above, we deduce the limit Level exceedance of 24-hour TSP recorded at station AM1 on 30 June 2021 is due to the non-project related influence. Therefore, the exceedance is considered as **non-project related**.

- 1. Watering of the construction areas 12 times per day to reduce dust emissions.
- 2. Side enclosure and covering of any aggregate or dusty material storage piles to reduce emissions.
- 3. Open stockpiles shall be avoided or covered.
- 4. Tarpaulin covering of all dusty vehicle loads transported to, from and between site locations.
- 5. Establishment and use of vehicle wheel and body washing facilities at the exit points of the site.
- 6. Imposition of speed controls for vehicles on unpaved site roads, 8 km per hour is the recommended limit.
- 7. Use of regular watering to reduce dust emissions from exposed site surfaces and unpaved roads, particularly during dry weather.

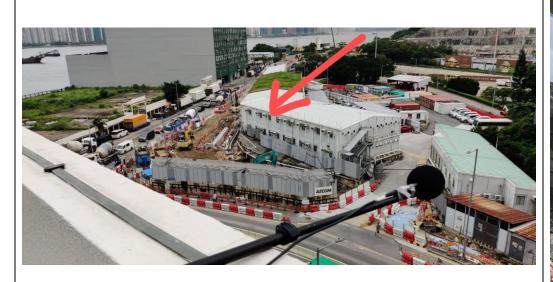
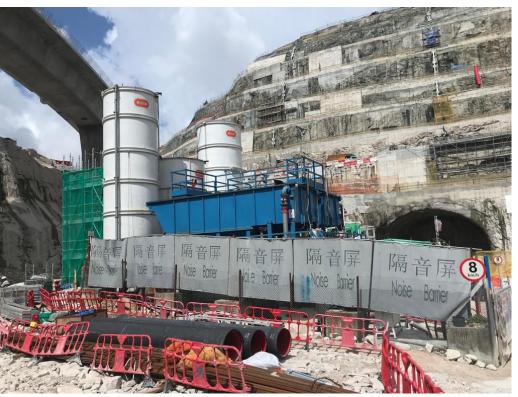
Photo 1 Photo 2

- 1. During both first time and repeated measurement, our field staff observed that breaking activity was carried out continuously on the site of TKOLTT. The noise generated by the breaker during breaking activity dominates the ambient or background noise. (See Photo 1)
- 2. Road traffic along Yau Tong Road.
- 3. Noise barriers were erected on the site of TKOLTT.
- 4. Noise barriers were erected on the site of Trunk Road T2.

Based on the finding(s) and observation(s) above, the limit level exceedance of construction noise recorded at station CM5 on 22 June 2021 was due to the construction activities of the TKOLTT project. Therefore, the exceedance is considered as **non-project related**.

- 1. Use of temporary or fixed noise barriers with a surface density of at least 10kg/m2 to screen noise from movable and stationary plant;
- 2. Use of acoustic fabric for the silent piling system, drill rigs, rock drills etc;
- 3. Only well-maintained plant should be operated on-site and plants should be serviced regularly during the construction period;
- 4. Mobile plant, if any, should be sited as far from NSRs as possible;
- 5. Use of site hoarding as a noise barrier to screen noise at low level NSRs;
- 6. Machines and plant that may be in intermittent use should be shut down between works periods or should be throttled down to a minimum; and
- 7. Any material stockpiles and other structures should be effectively utilized, wherever practicable, to screen the noise from on-site construction activities.
