Contract No. ED/2018/04

Trunk Road T2 and Infrastructure Works for Developments at the Former South Apron

Appendix N – Summary of Exceedance

Reporting Period: June 2022

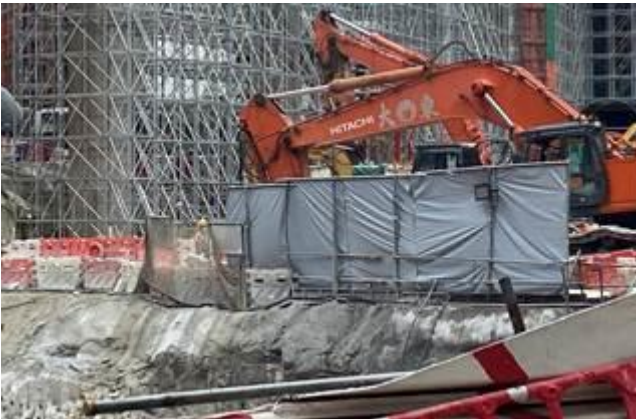
Photo 3 (Photo Taken by Contractor)

<p>(a) Statement of exceedance(s) Construction noise measured at CM1 exceeded the construction noise (day time) limit level.</p>
<p>(b) Cause of exceedance(s) According to the observation of our field staff, the major noise source(s) and/or reason(s) for exceedance identified at CM1 is/are as follow:</p> <ol style="list-style-type: none"> 1. A breaker was being operated at Portion IVB of TKOLTT during monitoring. Despite noise barrier was placed near at the breaker, it was not able to block the direct line of sight (See Photo 1 and 2). 2. Percussive / breaking noise from LTI and Portion IVB of TKOLTT were heard during the first measurement 3. Road traffic along the adjacent slip road approaching to EHC tunnel. <p>Review on the implementation of noise mitigation measures of the Project of Trunk Road T2:</p> <ol style="list-style-type: none"> 1. Noise barriers were erected on the site of Trunk Road T2 (See Photo 3 and 4).

Although the exceedance is considered as non-project related, it is recommended that the following construction noise mitigation measures shall always be implemented on site to reduce/ minimize the construction noise nuisance due to the construction activities.

1. Use of temporary or fixed noise barriers with a surface density of at least 10kg/m² to screen noise from movable and stationary plant;
2. Use of acoustic fabric for the silent piling system, drill rigs, rock drills etc;
3. Only well-maintained plant should be operated on-site and plants should be serviced regularly during the construction period;
4. Mobile plant, if any, should be sited as far from NSRs as possible;
5. Use of site hoarding as a noise barrier to screen noise at low level NSRs;
6. Machines and plant that may be in intermittent use should be shut down between works periods or should be throttled down to a minimum; and
7. Any material stockpiles and other structures should be effectively utilized, wherever practicable, to screen the noise from on-site construction activities.
