# Civil Engineering and Development Department

## Trunk Road T2 (under EP-458/2013/C)

### Monthly Environmental Monitoring and Audit Report for November 2021 (version 1.0)

**Re: Agreement No. EDO 01/2019  
Independent Environmental Checker for  
Contract No. ED/2018/04 – Trunk Road T2 and Infrastructure Works for  
Developments at the Former South Apron**

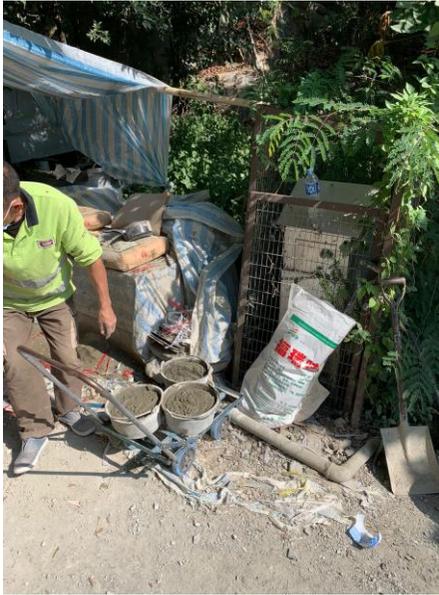
Photo 1 – Recent condition of the High Volume Sampler (HVS) at AM1, Tin Hau Temple.  
(Taken on 24 Nov 2021)

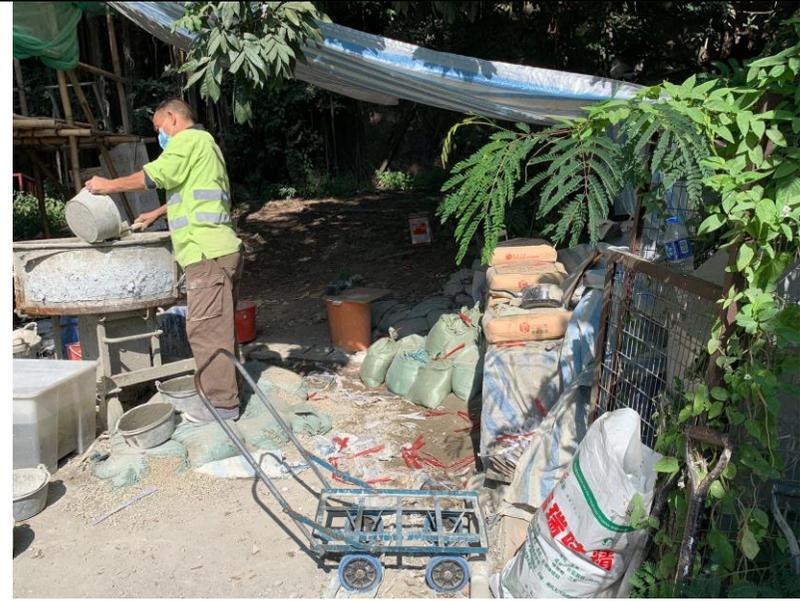
Photo 2 – Dust generating activities (cement mixing) by renovation staff at AM1, Tin Hau Temple. (Taken on 24 Nov 2021)
