Appendix L

Cumulative statistics on Environmental Complaints, Notifications of Summons and Successful Prosecution

Investigation Report for the Complaint Received on 9th February 2017

Reference No.:	20170209_complaint_c
Project:	Contract KL/2014/03 – Kai Tak Development – Stage 3 Infrastructure Works for Developments at the Southern Part of the Former Runway
Date of Complaint:	9 th February 2017
Background:	<p>A complaint received on 9th February 2017 was referred from EPD on 21st February 2017 and summarized as below:</p> <ul style="list-style-type: none"> No car washing machine was found in the construction site near the gate of former Radar Tower (hereinafter referred to as “the Site”). Dust was observed when the vehicle leaving and entering the Site. <p>The notification of complaint was received by ET on 22nd February 2017.</p>
Action taken during the investigation:	<ul style="list-style-type: none"> Site meeting between HMJV and CRBC was arranged at the Site at 1:30pm on 22nd February 2017 to investigate the complaint. Joint site audit was carried out by ET, HMJV and CRBC at the Site at 2:00pm on 23rd February 2017 to investigate the complaint. Joint site audit was carried o

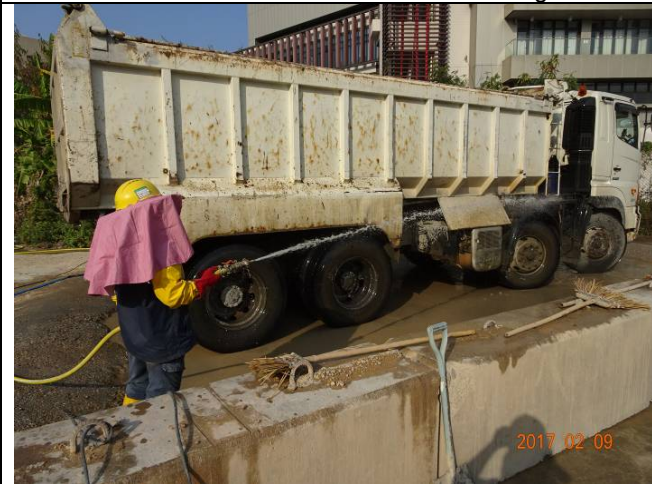
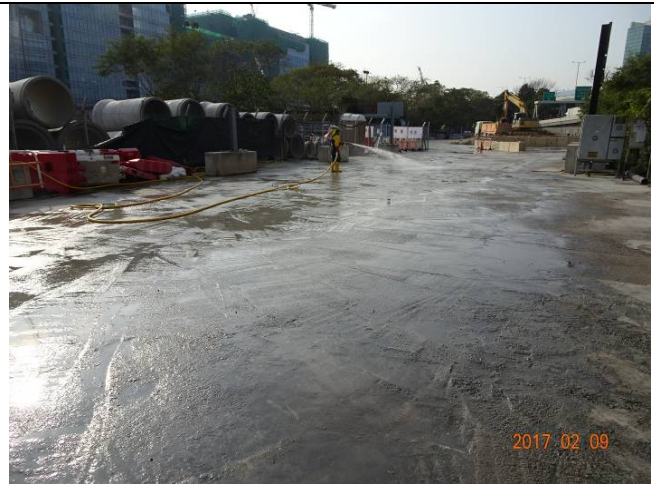
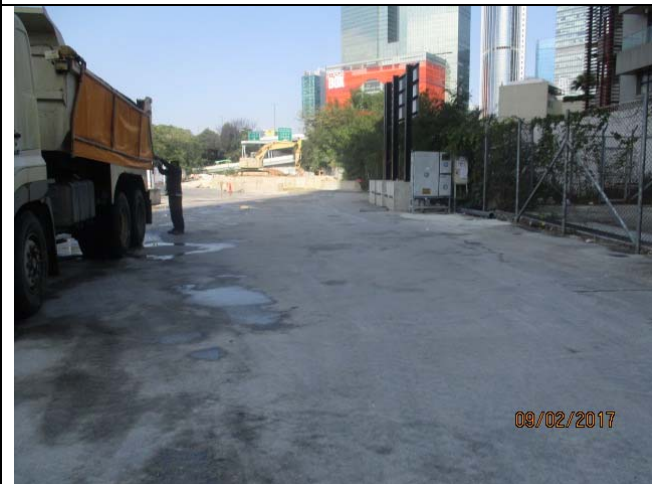
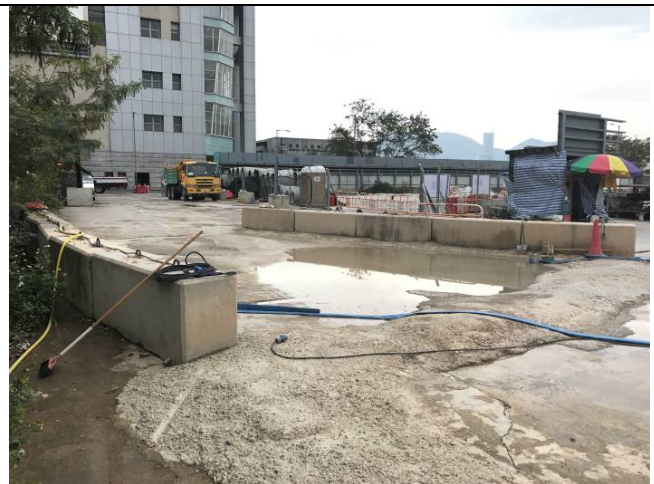
Source: HMJV

Vehicle washing facilities were observed at the Site on 9th February 2017. The area where vehicle washing takes place and the section of road between the washing facilities and the exit point were paved with hardcores. Vehicles were washed at site exit before leaving the Site.

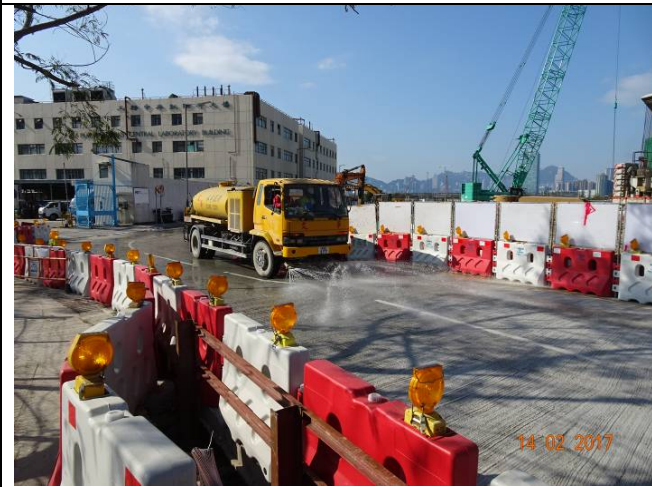
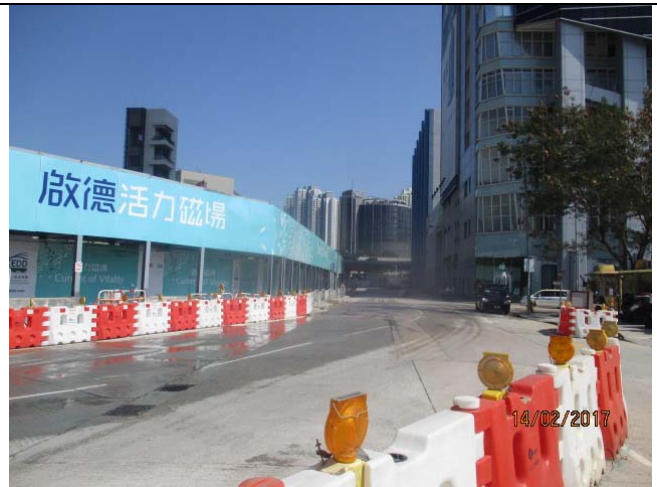
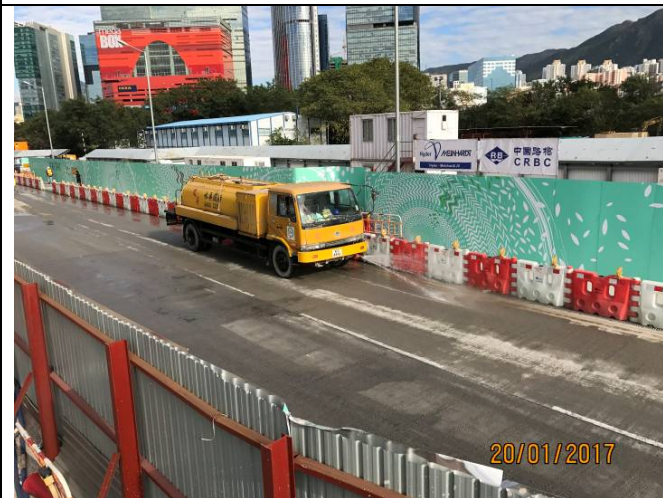
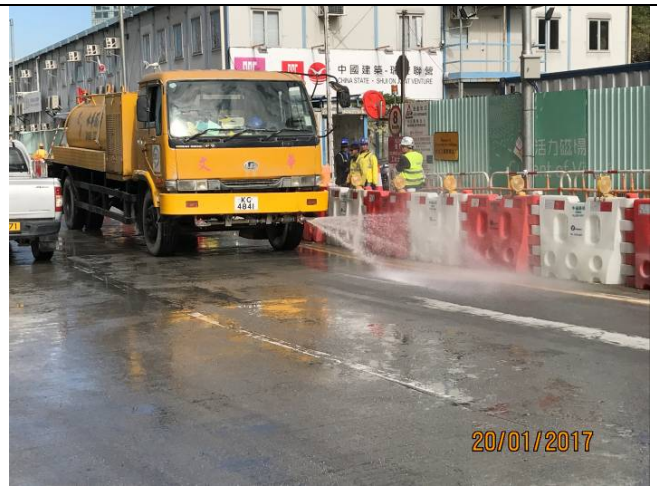
Source: HMJV

Cleaning of Cheung Yip Street by street sweep vehicles was carried out by the Contractor on 20th January 2017 and 14th February 2017.

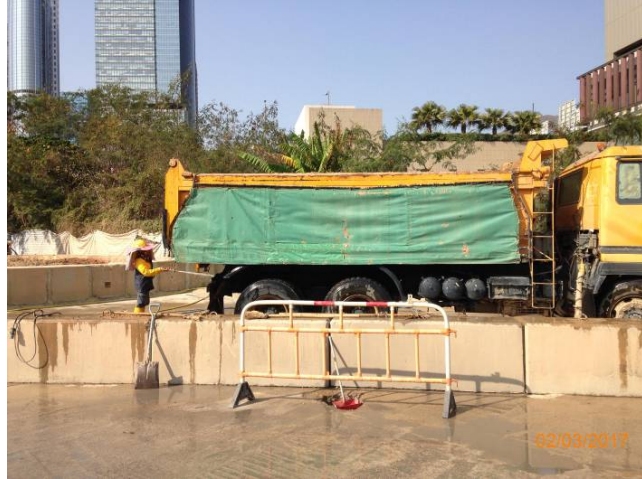
Source: ET

Thorough washing of vehicles before leaving the Site was observed by ET on 2nd March 2017.

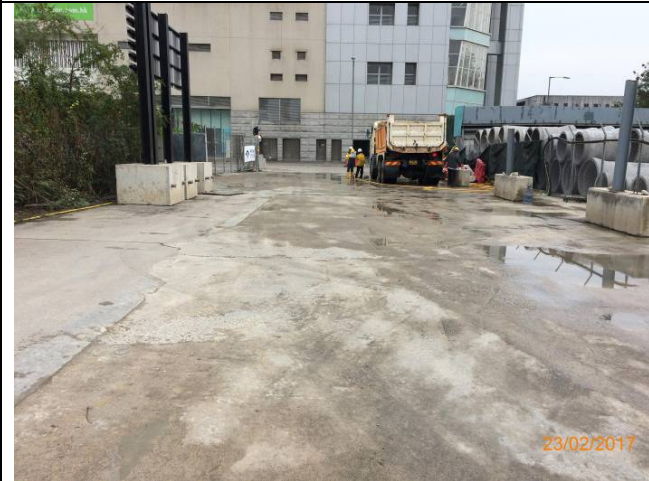
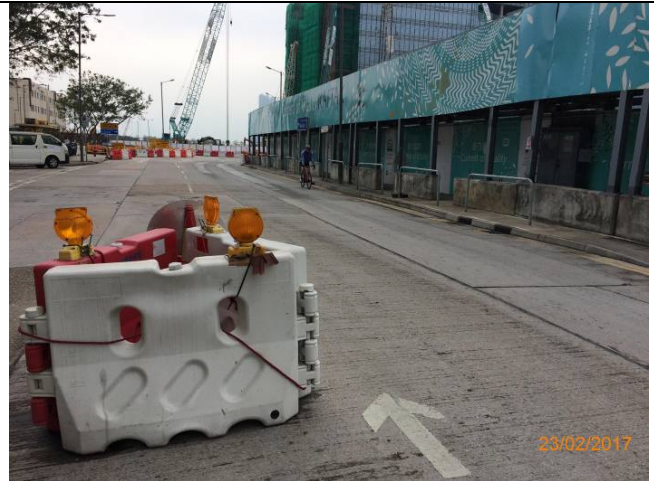
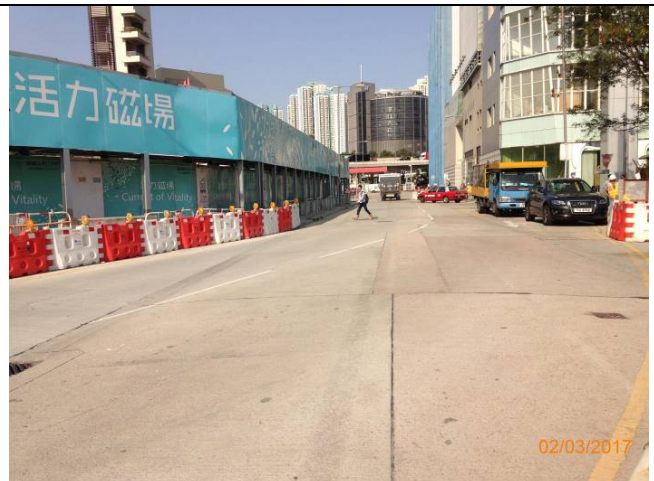
Source: ET

No dust or mud was observed by ET at the entrance of the Site and Cheung Yip Street on 23rd February 2017 and 2nd March 2017.
