MaterialLab**MONTHLY EM&A REPORT****October 2017**

Contract No. : KLN/2015/07

Contract Name : Environmental Monitoring Works for
Contract KL/2014/03 – Kai Tak Development
– Stage 3 Infrastructure Works for Developments
at the Southern Part of the Former Runway

Report No. : 0405/15/ED/0934A

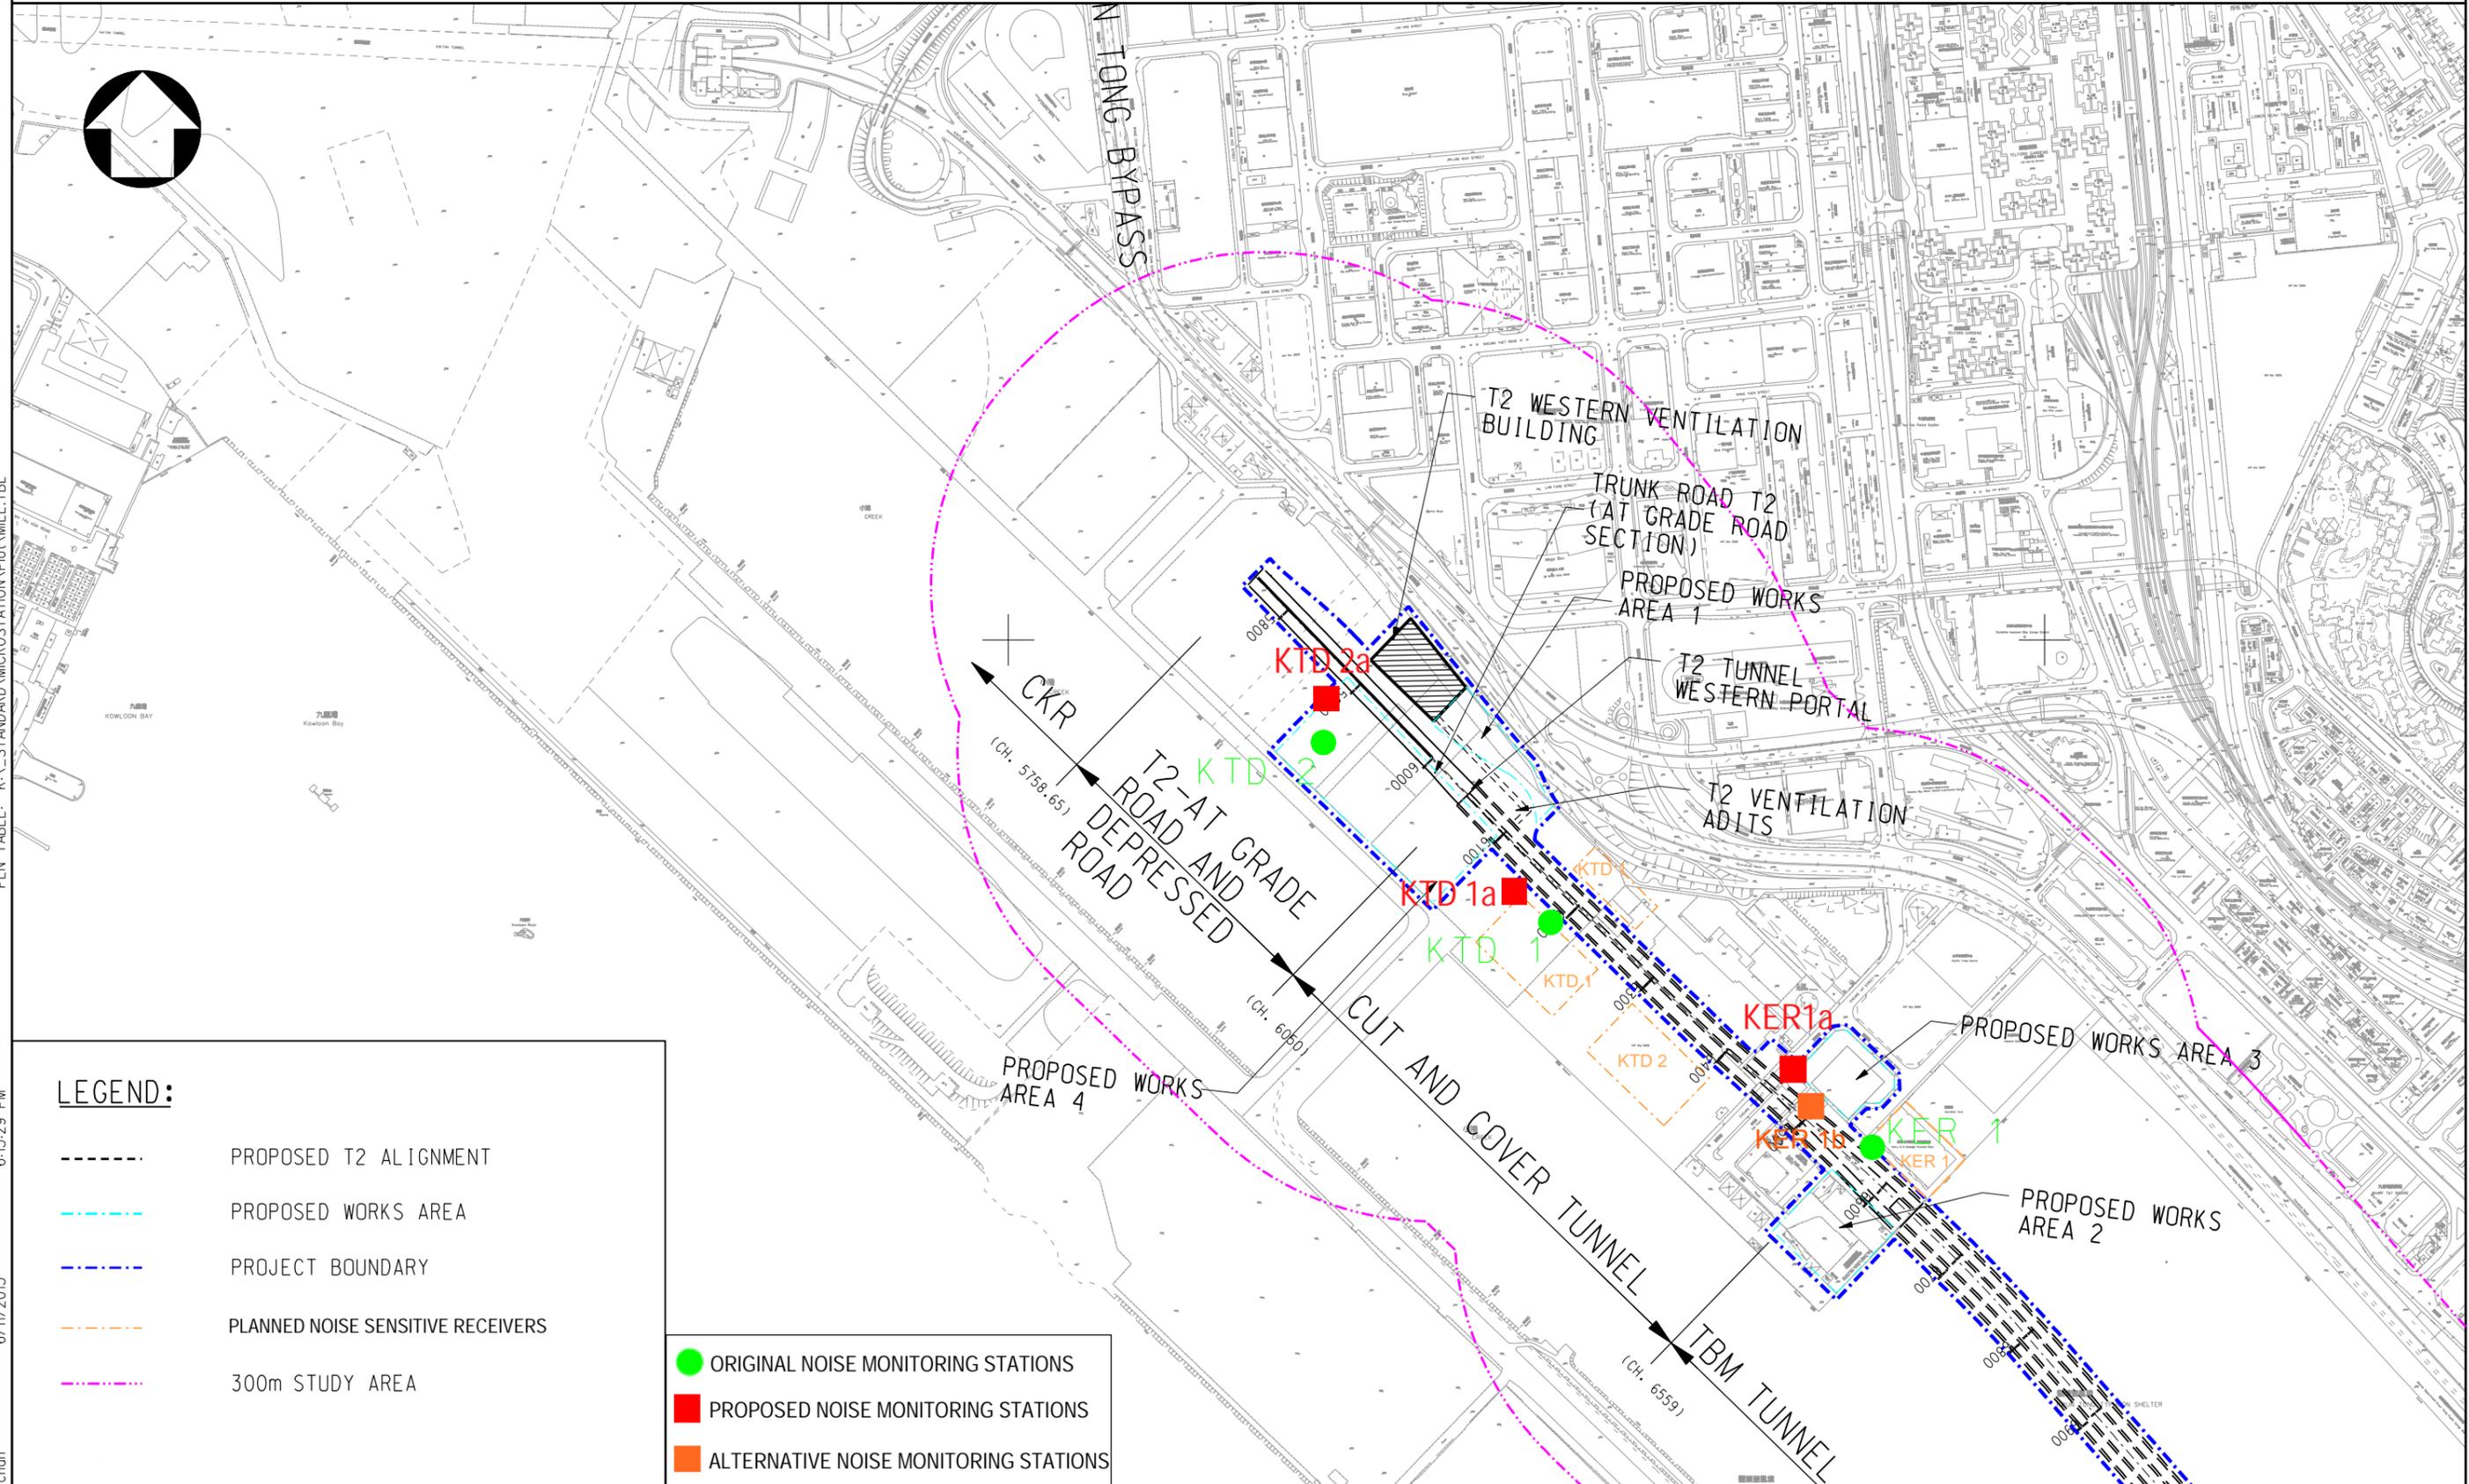
Figure 2

2.5.2 According to the approved alternative baseline air quality and noise monitoring locations (EPD reference: EP2/K19/A/21 Pt.5), the original monitoring locations (KTD1, KTD2 and KER1) are proposed to be replaced by alternative monitoring locations (KTD1a, KTD2a and KER1b) for air quality monitoring, they are summarized in **Table 2.2** and shown in **Figure 2**.

Air and Noise Monitoring Locations

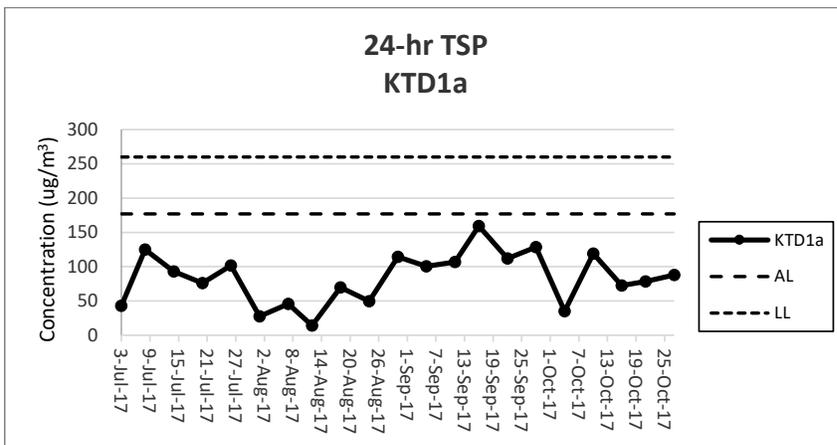
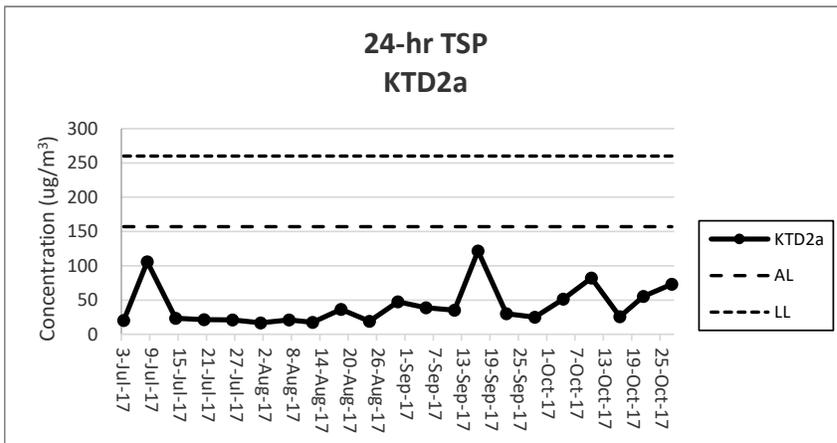
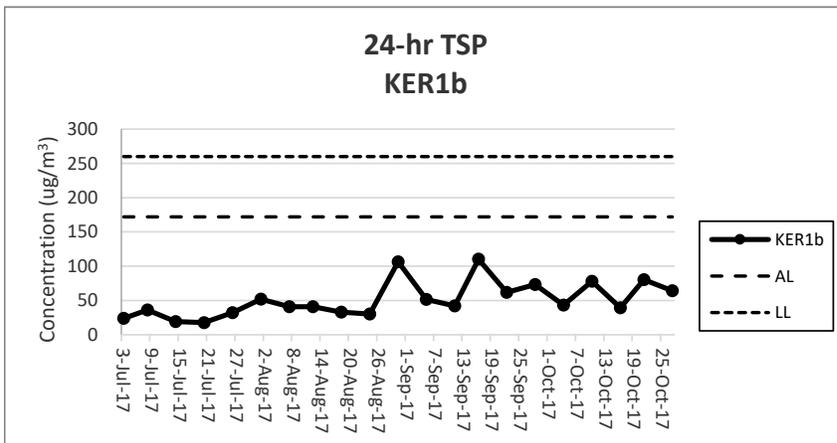
Start Date	Weather Condition	Air Temperature (K)	Atmospheric Pressure, Pa (mmHg)	Filter Weight (g)		Particulate weight (g)	Sampling Time(hrs)	Flow Rate (m ³ /min.)		Average flow (m ³ /min.)	Total volume (m ³)	Conc. (ug/m ³)	Action Level (ug/m ³)	Limit Level (ug/m ³)
				Initial	Final			Initial	Final					
4-Oct-17	Cloudy	301.7	760.6	2.6581	2.7336	0.0755	24	1.50	1.51	1.50	2162.2	35	177	260
10-Oct-17	Fine	302.8	758.2	2.6868	2.9545	0.2677	24	1.56	1.57	1.56	2250.8	119		
16-Oct-17	Cloudy	300.5	756.1	2.5651	2.7299	0.1648	24	1.53	1.64	1.58	2277.2	72		
21-Oct-17	Fine	296.6	759.1	2.8295	3.0147	0.1852	24	1.64	1.64	1.64	2357.1	79		
27-Oct-17	Fine	297.9	760.0	2.8340	3.0330	0.1990	24	1.57	1.57	1.57	2262.1	88		
												Min		
												Max	119	
												Average	79

Start Date	Weather Condition	Air Temperature (K)	Atmospheric Pressure, Pa (mmHg)	Filter Weight (g)		Particulate weight (g)	Sampling Time(hrs)	Flow Rate (m ³ /min.)		Average flow (m ³ /min.)	Total volume (m ³)	Conc. (ug/m ³)	Action Level (ug/m ³)	Limit Level (ug/m ³)
				Initial	Final			Initial	Final					
4-Oct-17	Cloudy	301.7	756.4	2.6779	2.7931	0.1152	24	1.55	1.57	1.56	2246.9	51	157	260
10-Oct-17	Fine	302.8	758.2	2.6806	2.8566	0.1760	24	1.48	1.49	1.49	2140.8	82		
16-Oct-17	Cloudy	300.5	756.1	2.5678	2.6255	0.0577	24	1.56	1.57	1.56	2249.3	26		
21-Oct-17	Fine	296.6	759.1	2.8135	2.9447	0.1312	24	1.64	1.64	1.64	2366.3	55		
27-Oct-17	Fine	297.9	760.0	2.6618	2.8271	0.1653	24	1.57	1.57	1.57	2258.3	73		
												Min		
												Max	82	
												Average	58

Start Date	Weather Condition	Air Temperature (K)	Atmospheric Pressure, Pa (mmHg)	Filter Weight (g)		Particulate weight (g)	Sampling Time(hrs)	Flow Rate (m ³ /min.)		Average flow (m ³ /min.)	Total volume (m ³)	Conc. (ug/m ³)	Action Level (ug/m ³)	Limit Level (ug/m ³)
				Initial	Final			Initial	Final					
4-Oct-17	Cloudy	301.7	760.6	2.7008	2.7886	0.0878	24	1.40	1.41	1.41	2024.7	43	172	260
10-Oct-17	Fine	302.8	758.2	2.6816	2.8255	0.1439	24	1.27	1.29	1.28	1843.5	78		
16-Oct-17	Cloudy	300.5	756.1	2.6874	2.7600	0.0726	24	1.28	1.29	1.28	1846.2	39		
21-Oct-17	Fine	296.6	759.1	2.8486	2.9980	0.1494	24	1.29	1.29	1.29	1855.6	81		
27-Oct-17	Fine	297.9	760.0	2.8255	2.9500	0.1245	24	1.35	1.35	1.35	1942.8	64		
												Min		
												Max	81	
												Average	61

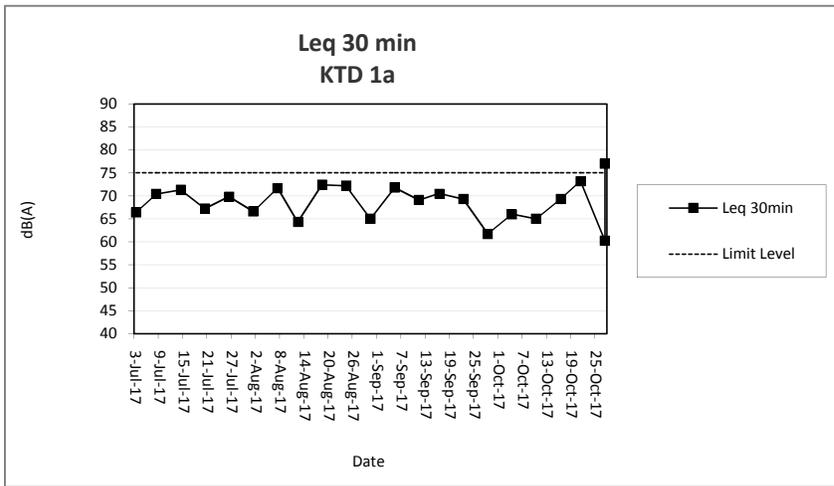
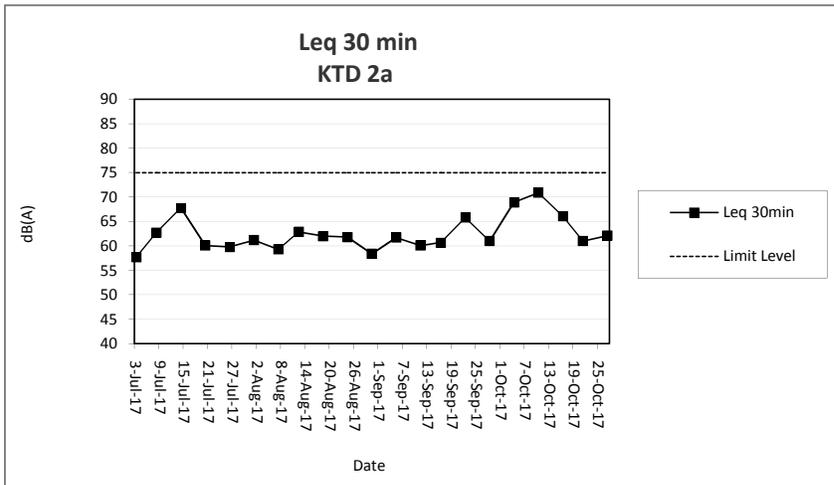
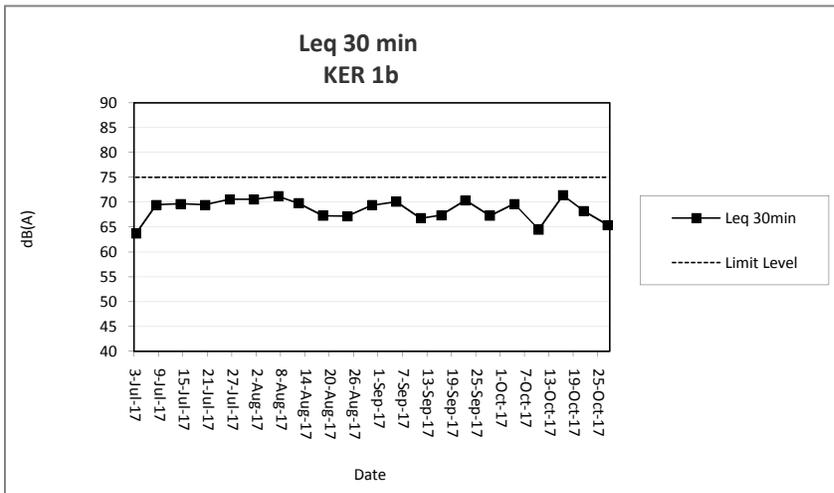
3.7.5 For the monitoring location KTD 1a, the measured noise level (77 dB(A)) on 27TH October 2017 exceeded the limit level. Piling noise from the Children Hospital was observed by our staff during noise monitoring. Repeat measurement was conducted to confirm the finding and the measured noise level (60 dB(A)) was below the limit level. Only vehicle noise along Shing Fung Road was observed in the second noise monitoring.

KTD2a & KER1b: Free-field measurement (+3dB(A) correction has been applied)
