MONTHLY EM&A REPORT

July 2019

Contract No. : KLN/2015/07

Contract Name : Environmental Monitoring Works for
Contract KL/2014/03 – Kai Tak Development
– Stage 3 Infrastructure Works for Developments
at the Southern Part of the Former Runway

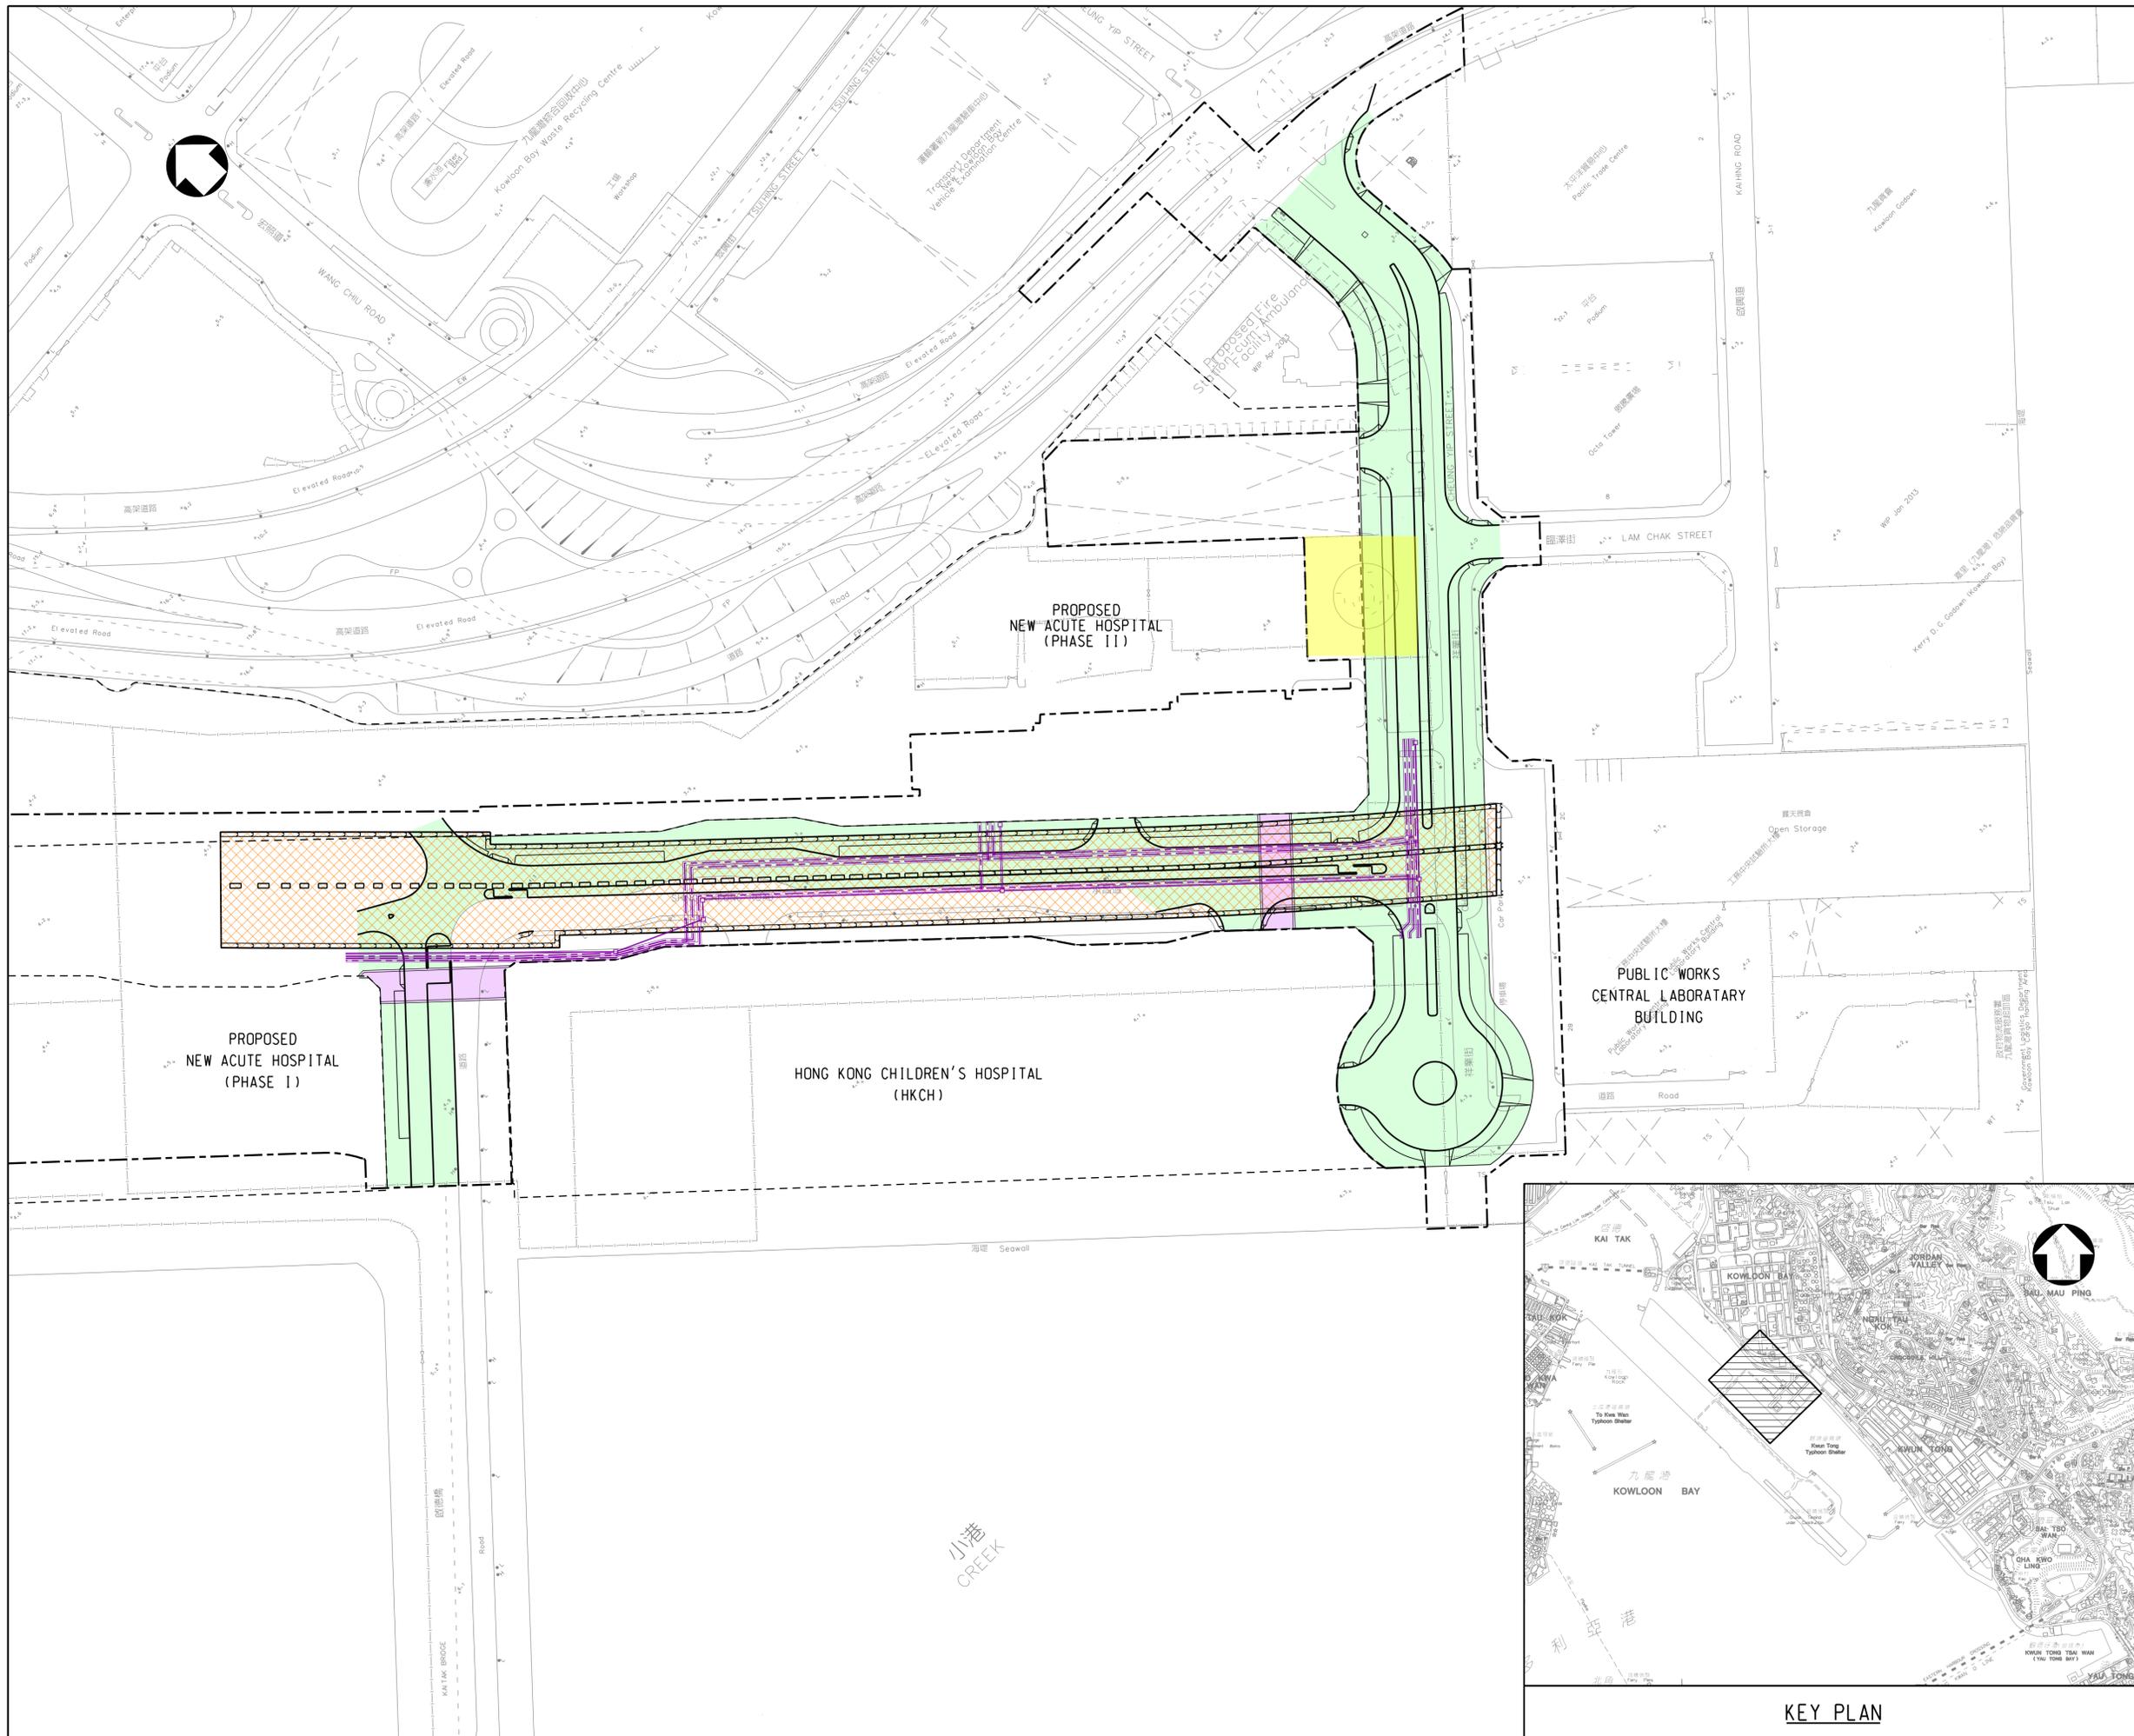
Figure 1

Project General Layout
